GPR report

2 February 2020

REDACTED, Executive Vice President, KasCon, requested GPR services in support of a Stein Sperling build-out located at 1101 Wootton Parkway, Rockville, Maryland on 21 January 2020. The project consists of multiple proposed penetrations on the 6th and 7th floors. The customer advised the columns/beams of this building contain post-tension cables, and were to be avoided on the job site. The remaining slab was believed to contain only rebar, which was to be marked on the slab so as to avoid while core drilling. GPR scanning was conducted on the 22-23, and 25 January 2020 on both floors; however, this GPR report will only contain the findings from the 7th floor, as the previous GPR report, dated 26 January 2020, articulated the 6th floor GPR findings. The remaining 7th floor scans, comprised of forty-four (44) scans were conducted on 31 January and 1 February 2020. To the extent possible, 2D or line scanning, was requested by the customer. However, due to site conditions, the shape of the building and consistently changing rebar patterns as a direct result, combined with multiple targets identified suggesting the presence of conduit and/or possible post ten

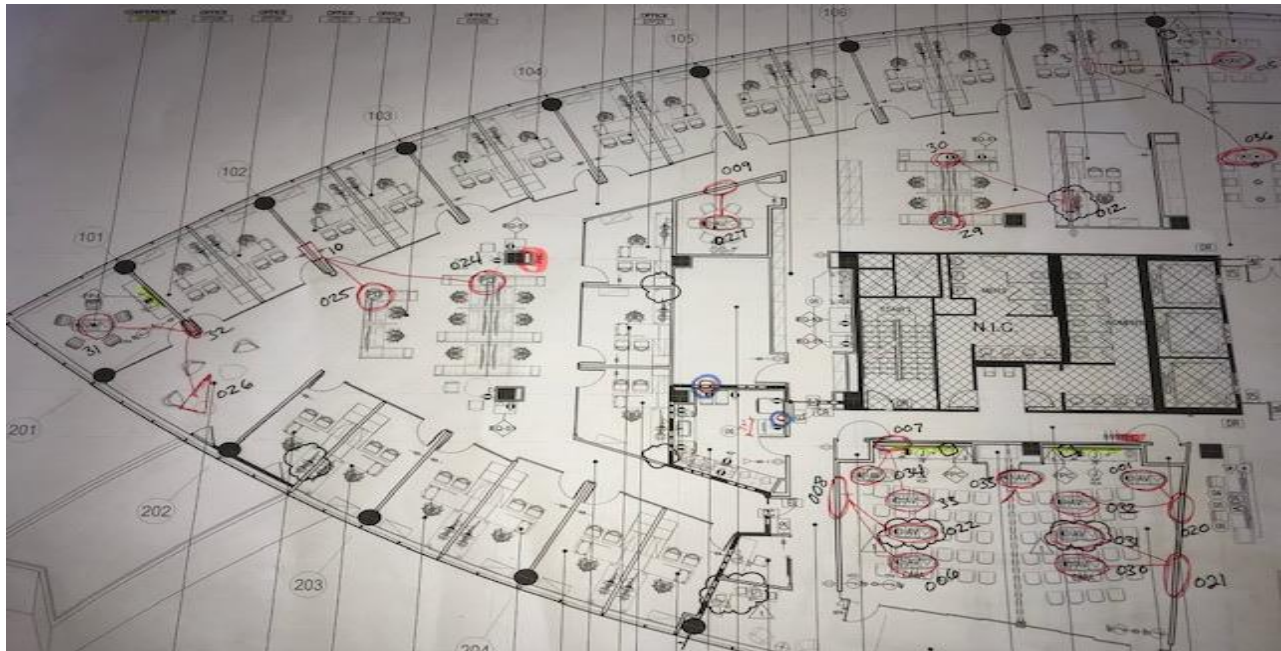
Image #1: This photo contains the south side of the existing 7th floor plan, with approximately half of the 46 corresponding proposed penetration areas, marked in red, that were scanned using GPR.

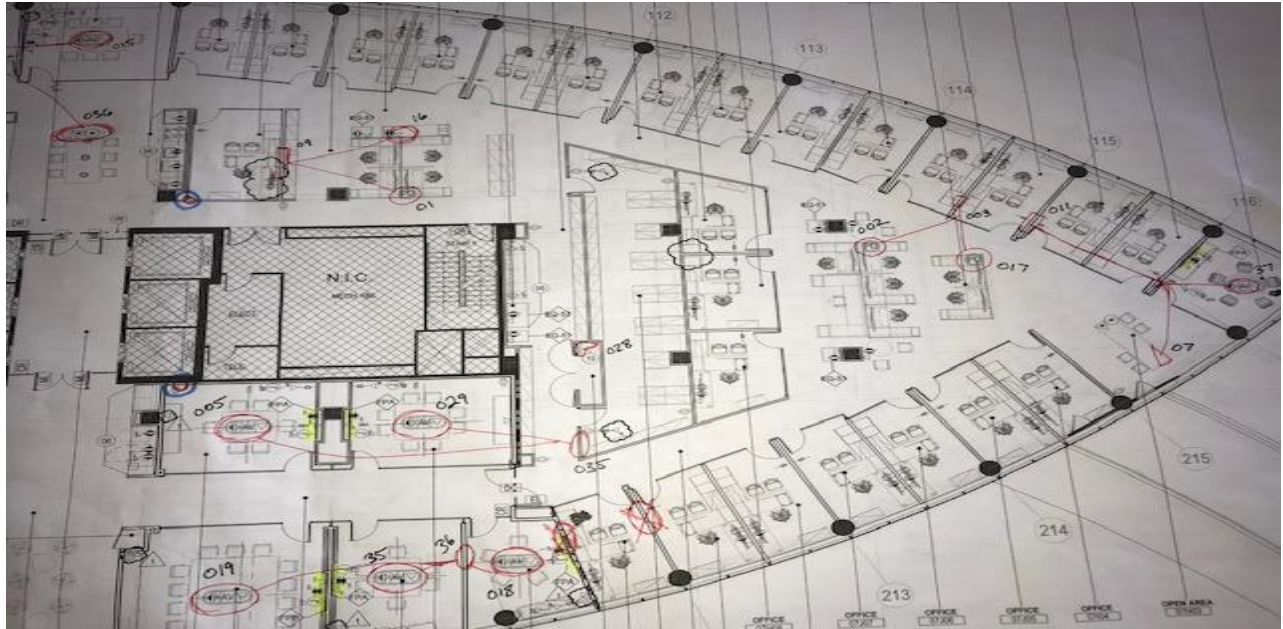
Image #2: This photo contains the north side of the existing 7th floor plan, with approximately half of the 46 corresponding proposed penetration areas, marked in red, that were scanned using GPR.

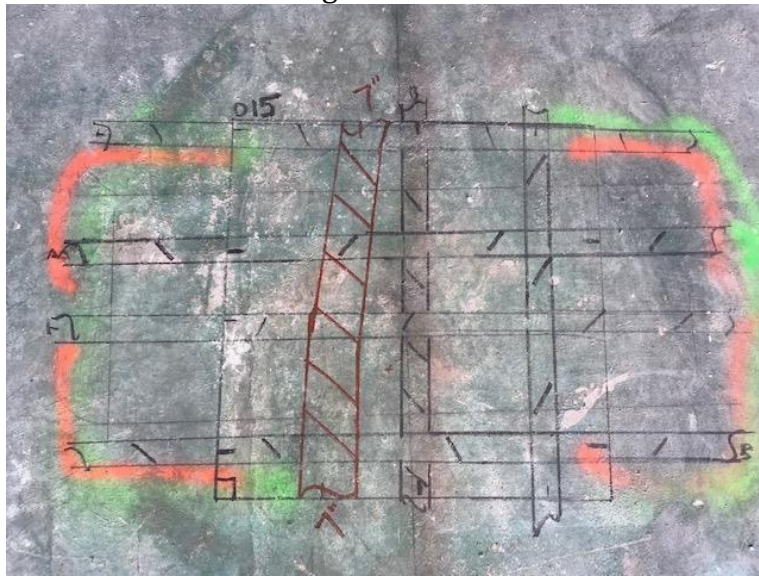
Scan #1/Denoted as 015: This scan shows an 8" slab with top and bottom layers of rebar, with a possible conduit at a depth of 8".

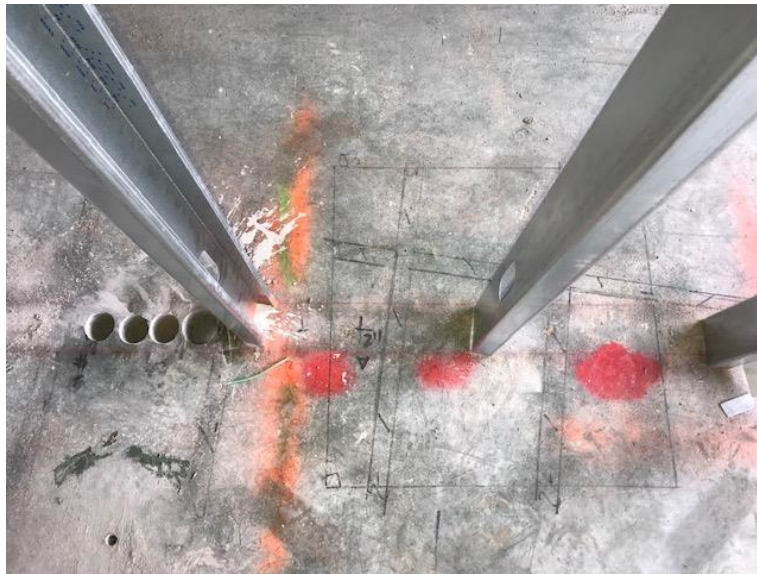
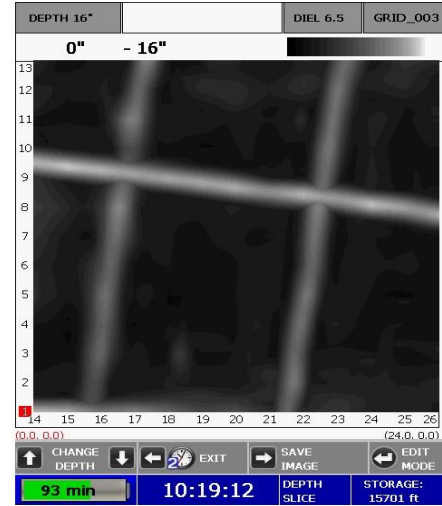
Scan #2/Denoted as 03: This scan shows an 8" slab with a bottom layer of rebar.

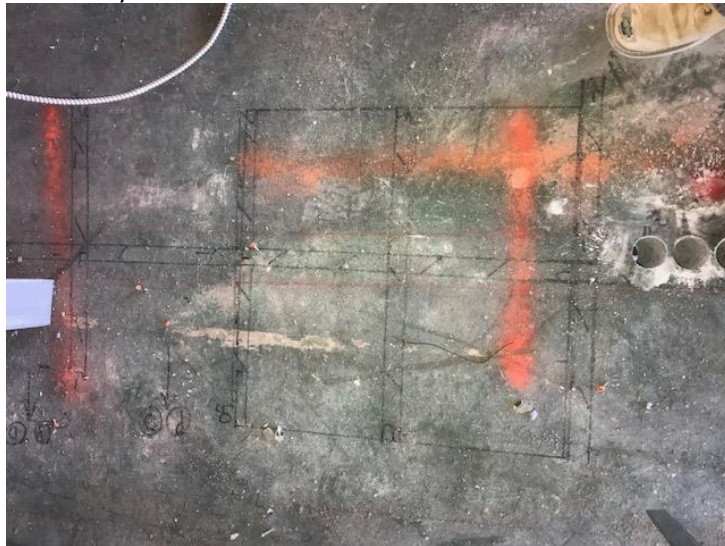
Scan #3/Denoted at 09: This scan shows an 8" slab with top layer of rebar.

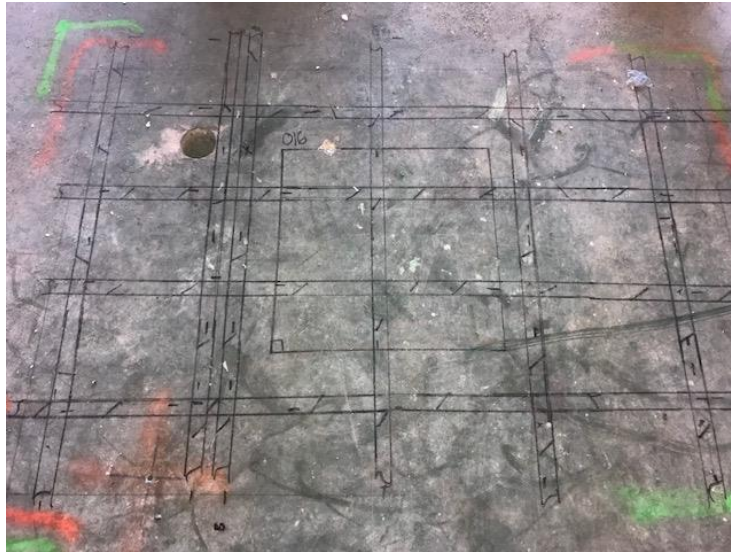
Scan #4/Denoted at 016: This scan shows an 8" slab with top and bottom layers of rebar.

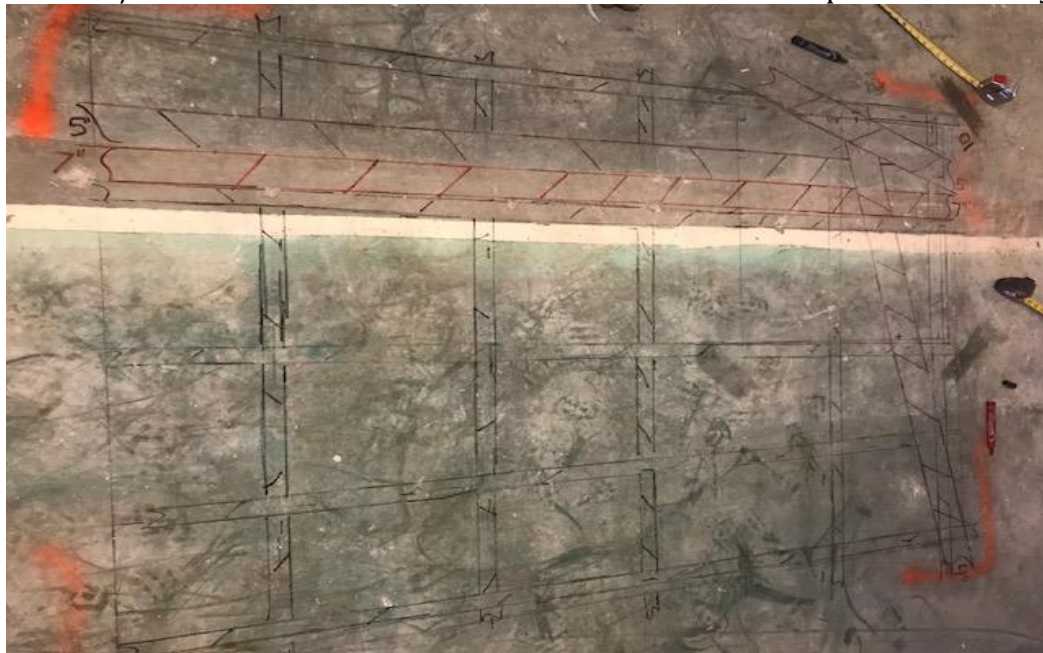
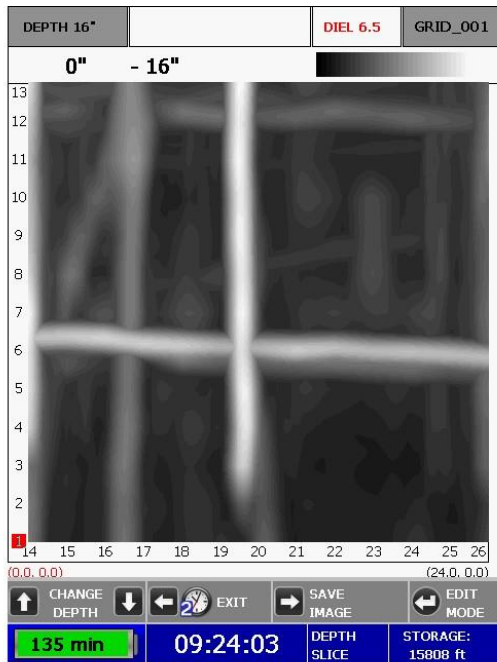
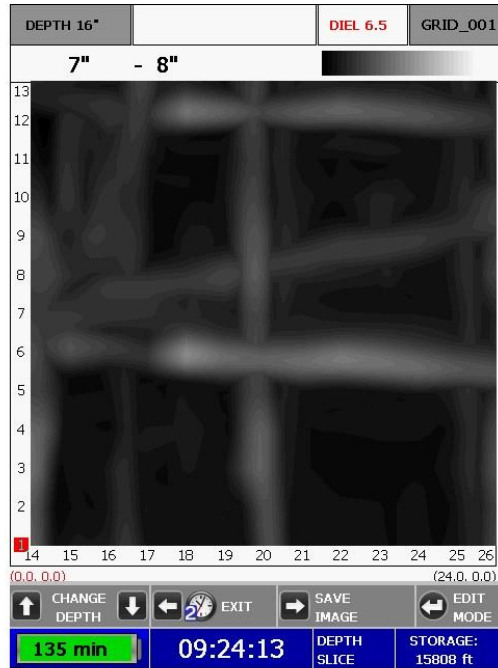
Scan #5/Denoted at 01: This scan shows an 8" slab with top and bottom layers of rebar. Three likely conduits, identified at between 4"-7" in depth, were identified and marked in red, to avoid.

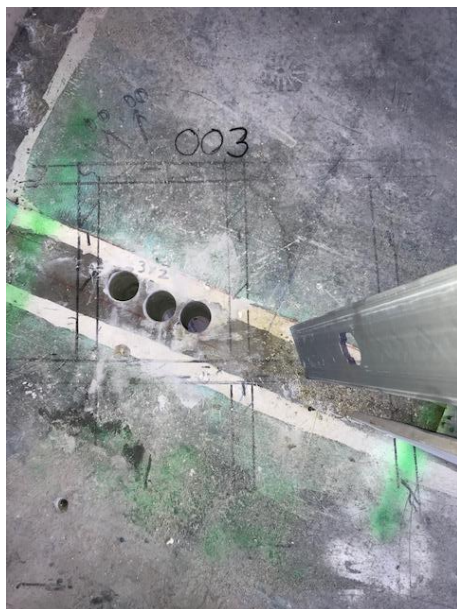
Scan #6/Denoted at 003: This scan shows an 8" slab with top and bottom layers of rebar.

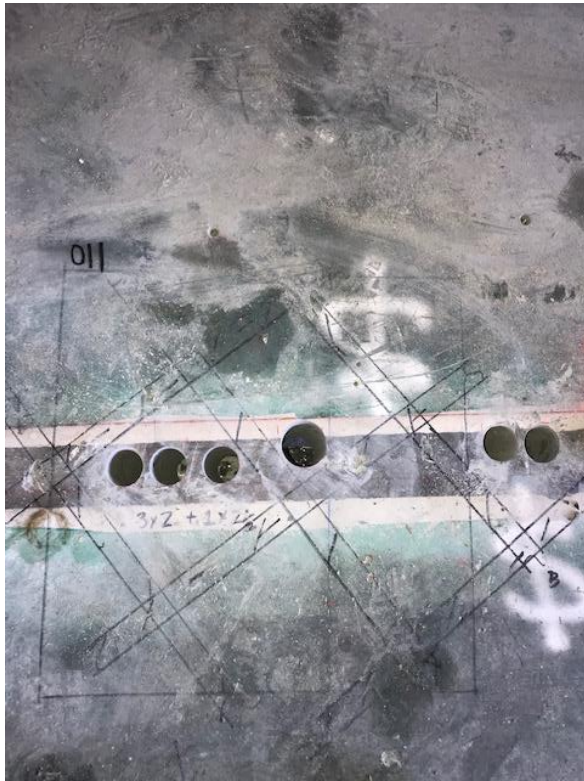
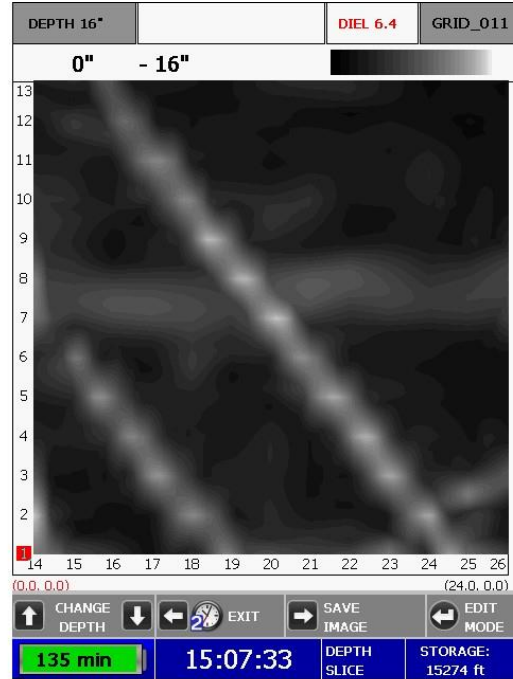
Scan #7/Denoted at 011: This scan shows an 8" slab with top and bottom layers of rebar.

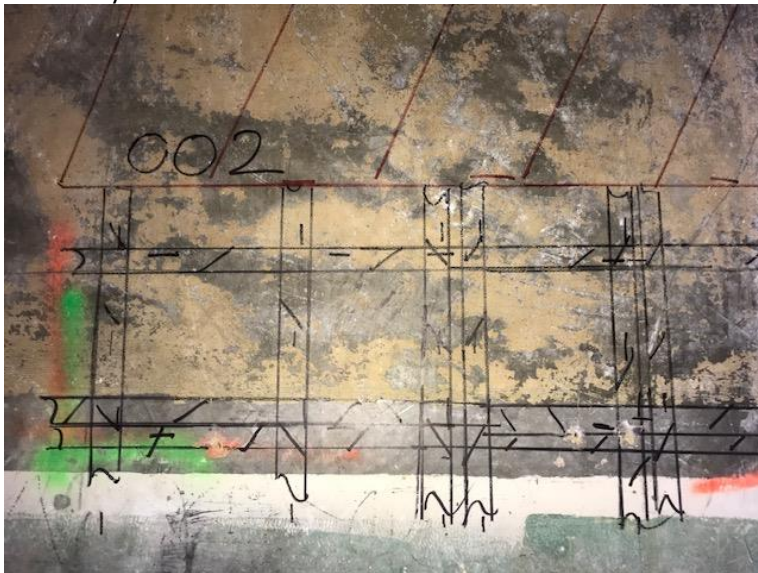
Scan #8/Denoted as 002: This scan shows an 8" slab with top and bottom layers of rebar, abutting a post-tension beam which was marked in red, to avoid.

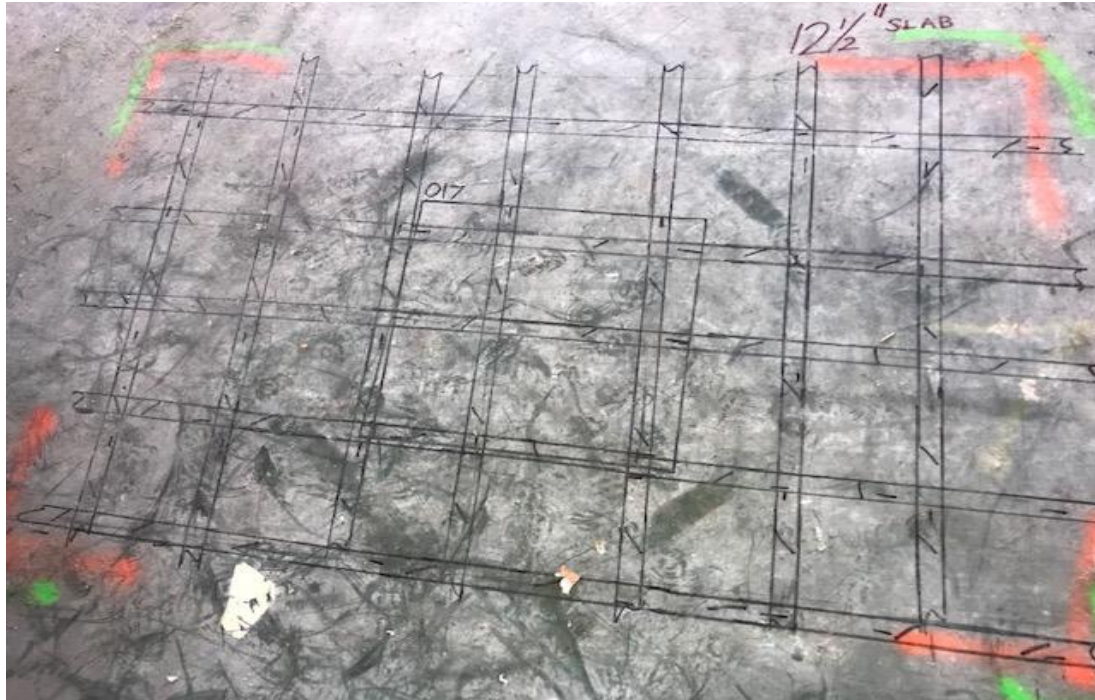
Scan #9/Denoted as 017: This scan shows a 12.5" slab with a bottom layer of rebar.

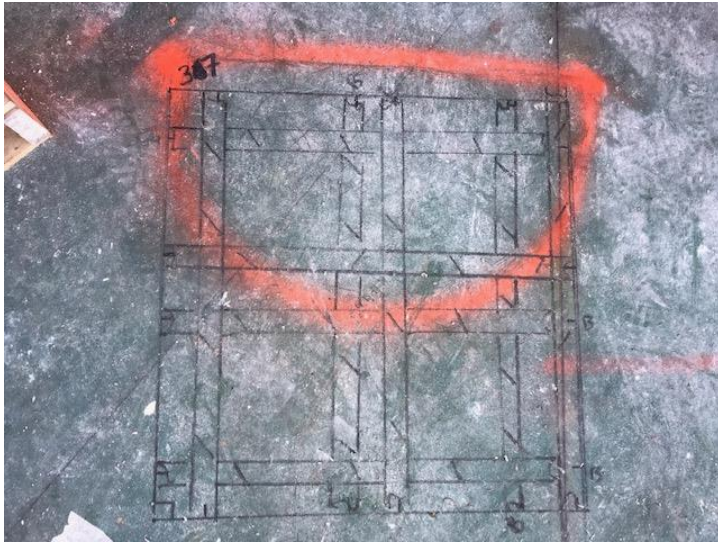
Scan #10/Denoted as 37: This scan shows an 8" slab with top and bottom layers of rebar.

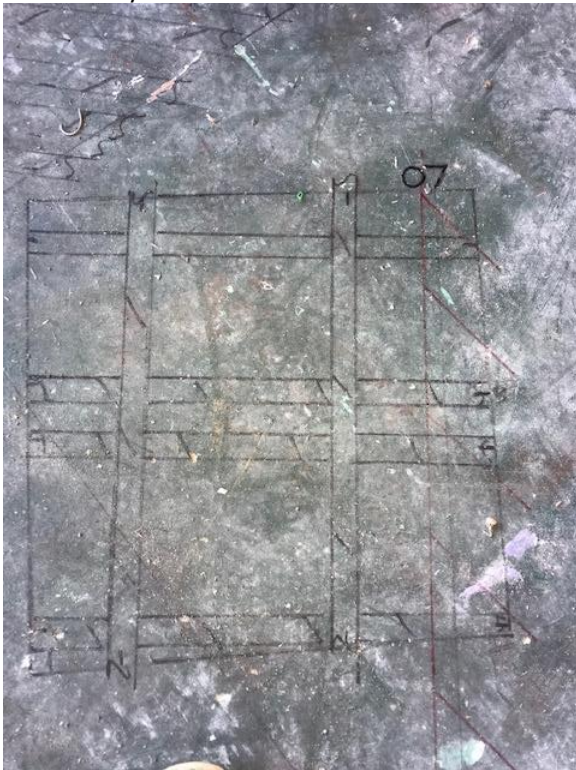
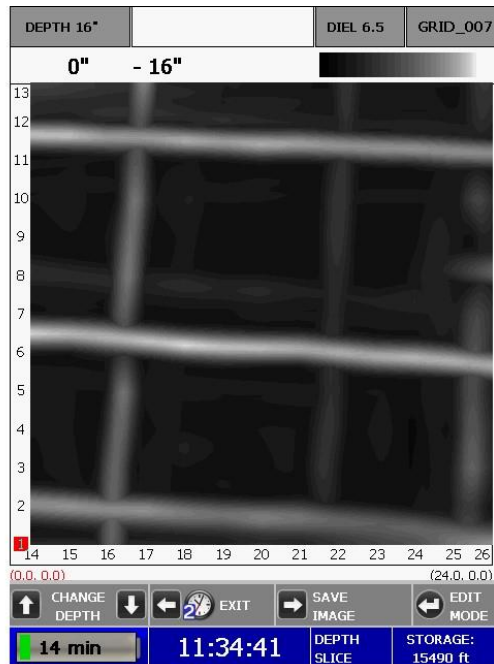
Scan #11/Denoted as 07: This scan shows an 8" slab with top and bottom layers of rebar. This scan abuts a post-tension beam and was marked in red, to avoid.

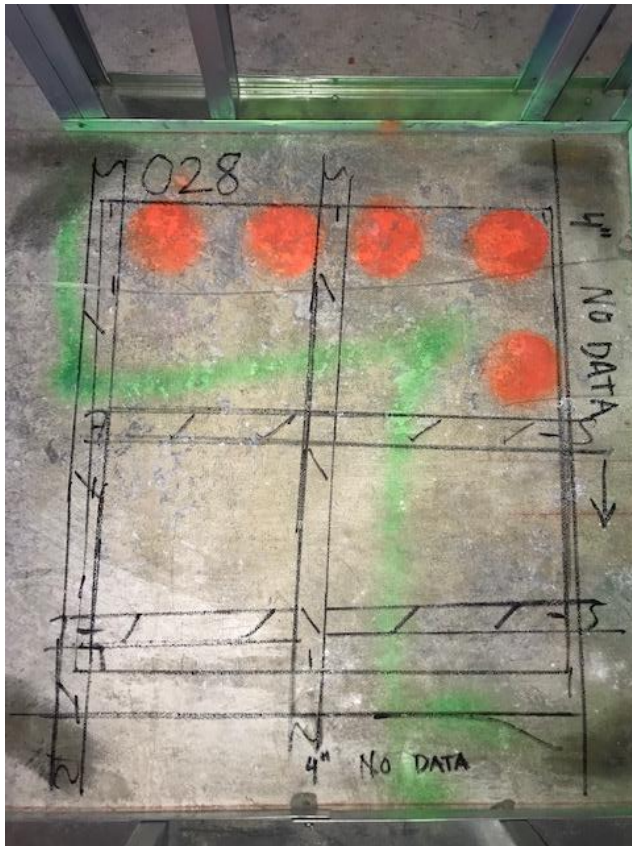
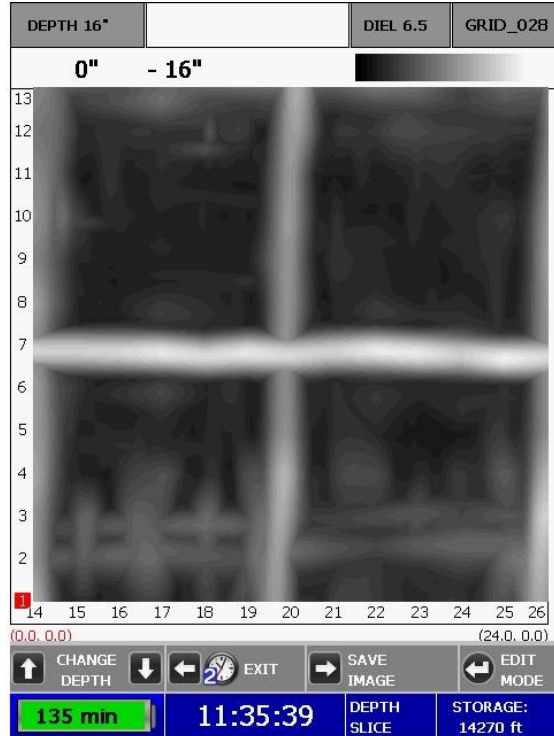
Scan #13/Denoted as 028: This scan shows an 8" slab with a bottom layer of rebar. As explained to the custom, GPR requires 4" clearance on all sides. As this scan was surrounded by track on three sides, the 4" clearance was marked as "no data."

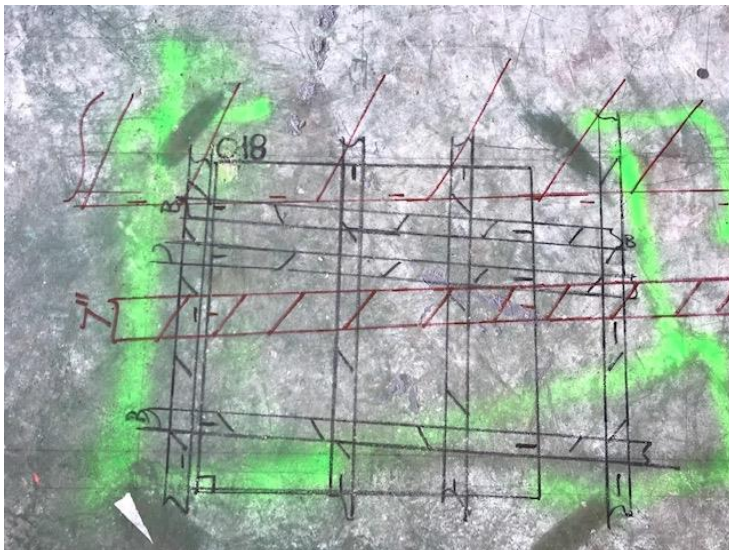
Scan #14/Denoted as 018: This scan shows an 8" slab with top and bottoms layer of rebar, with a conduit at a depth of 7". This scan abuts a post-tension beam, which was marked in red to avoid.

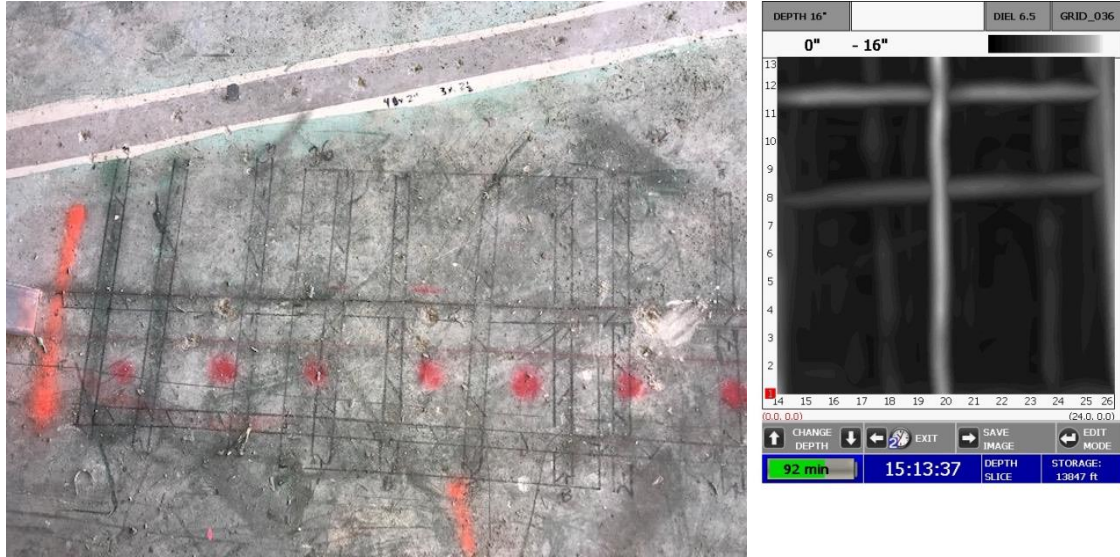
Scan #15/Denoted as 036: This scan shows an 8" slab with a top and bottom layer of rebar.

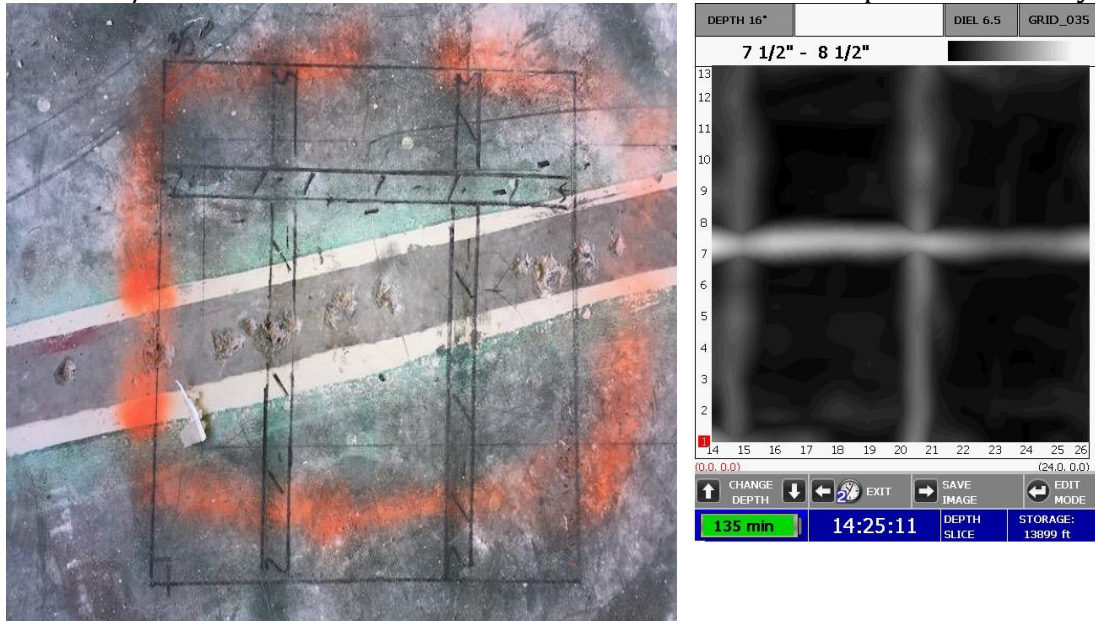
Scan #16/Denoted as 035: This scan shows an 8" slab with a bottom layer of rebar.

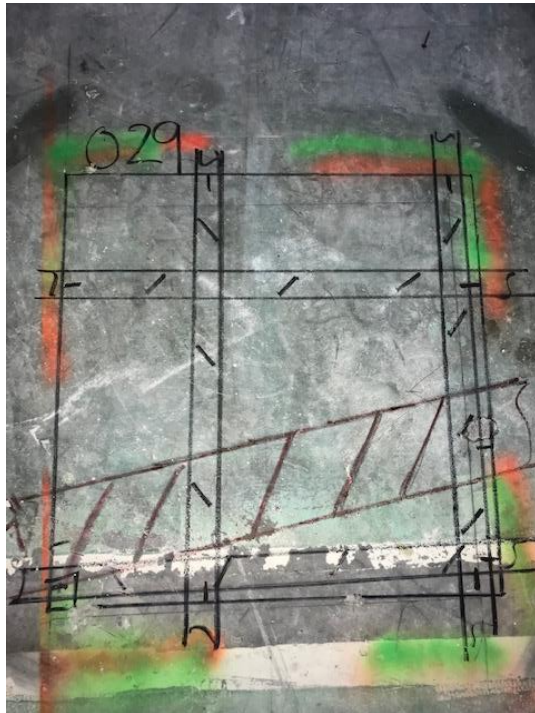
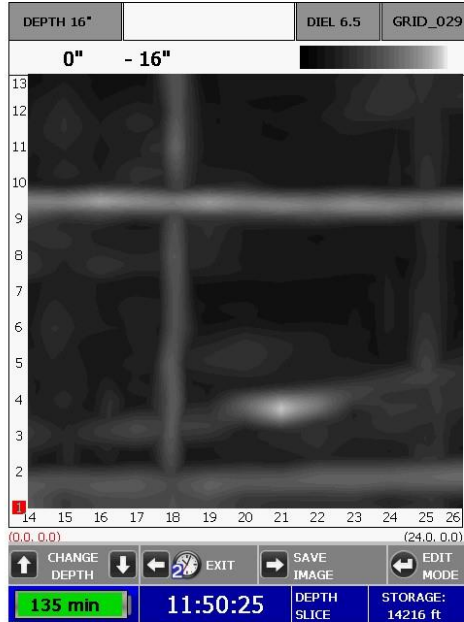
Scan #17/Denoted as 029: This scan shows an 8" slab with a bottom layer of rebar and a conduit at a depth of 7" running horizontally through the grid.

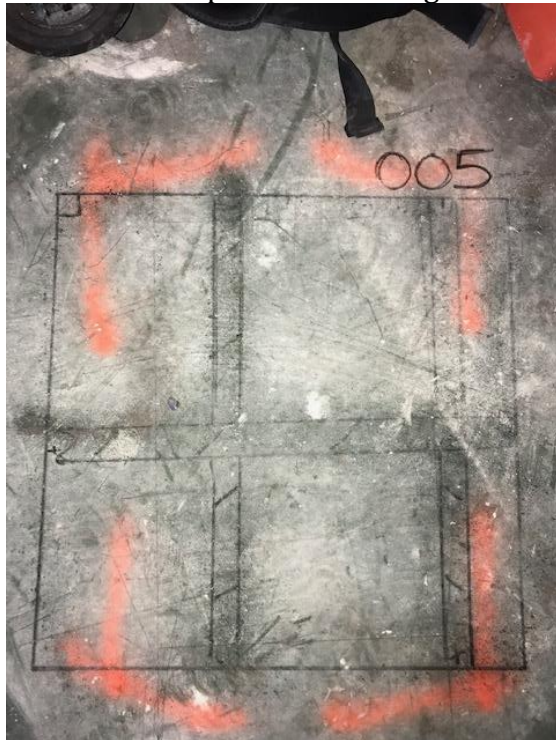
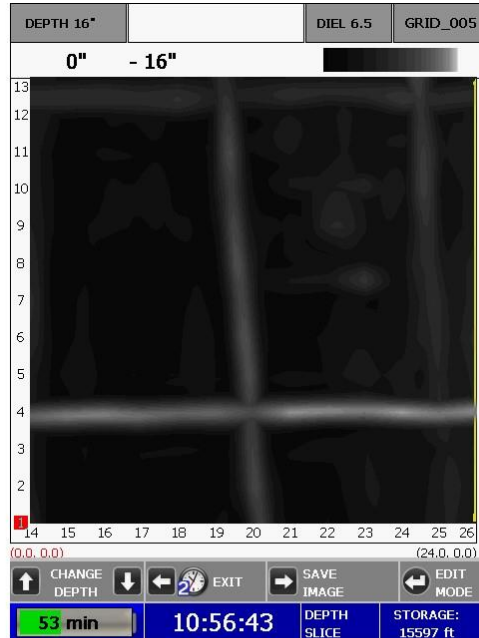
Scan #18/Denoted as 005: This scan shows an 8" slab with a top and bottom layer of rebar.

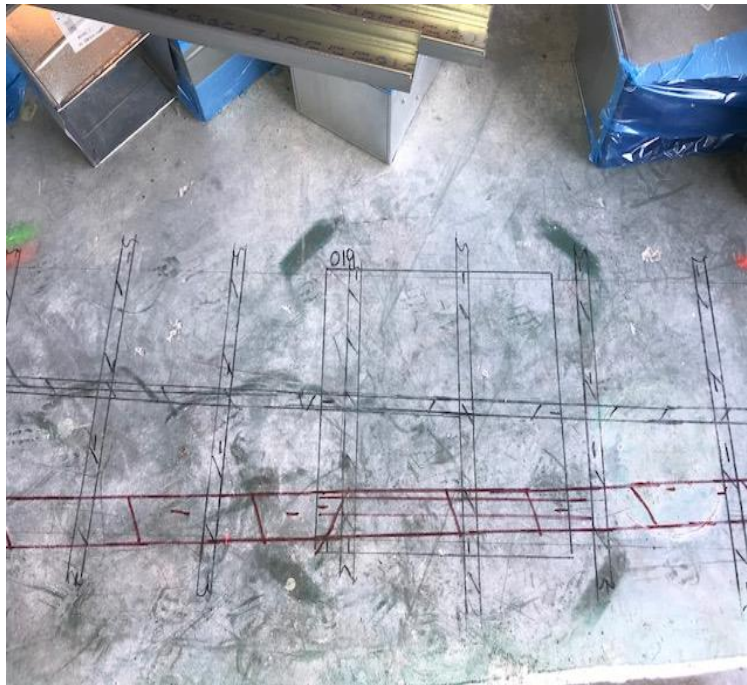
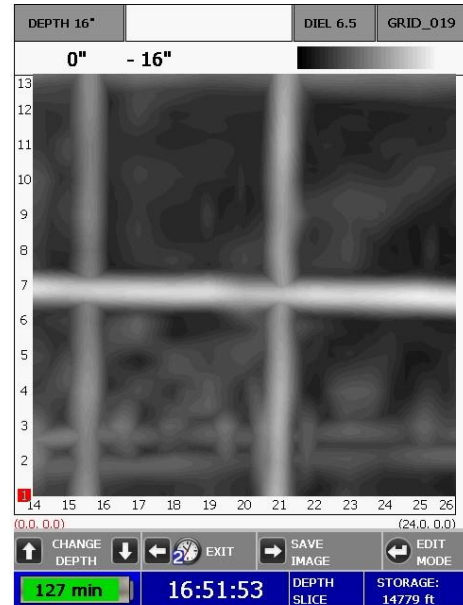
Scan #19/Denoted as 019: This scan shows an 8" slab with a top and bottom layer of rebar, and a possible conduit running horizontally through the grid.

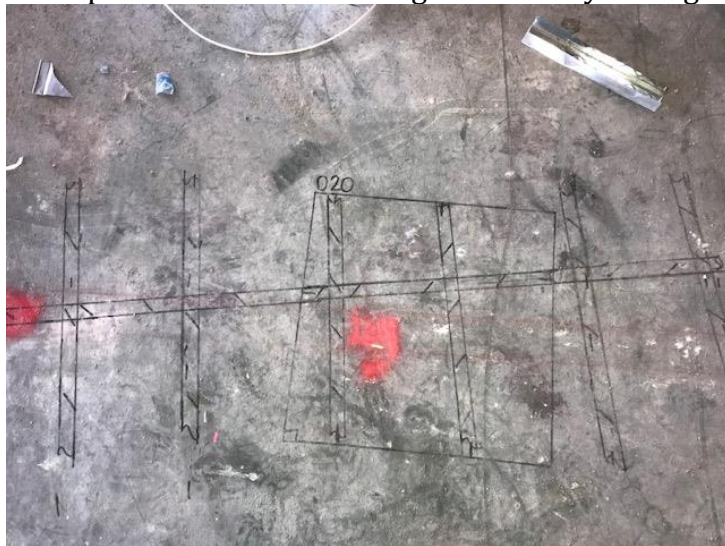
Scan #20/Denoted as 020: This scan shows an 8" slab with a bottom layer of rebar.

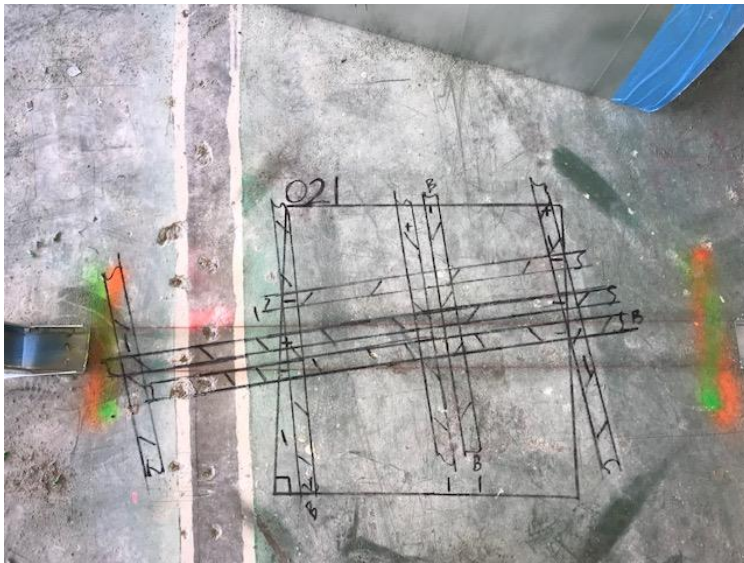
Scan #21/Denoted as 021: This scan shows an 8" slab with top and bottom layers of rebar.

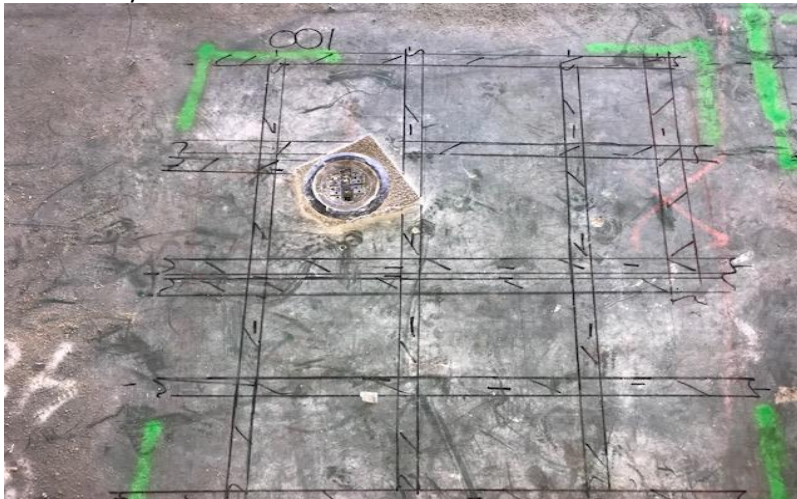
Scan #22/Denoted as 001: This scan shows an 8" slab with top and bottom layers of rebar.

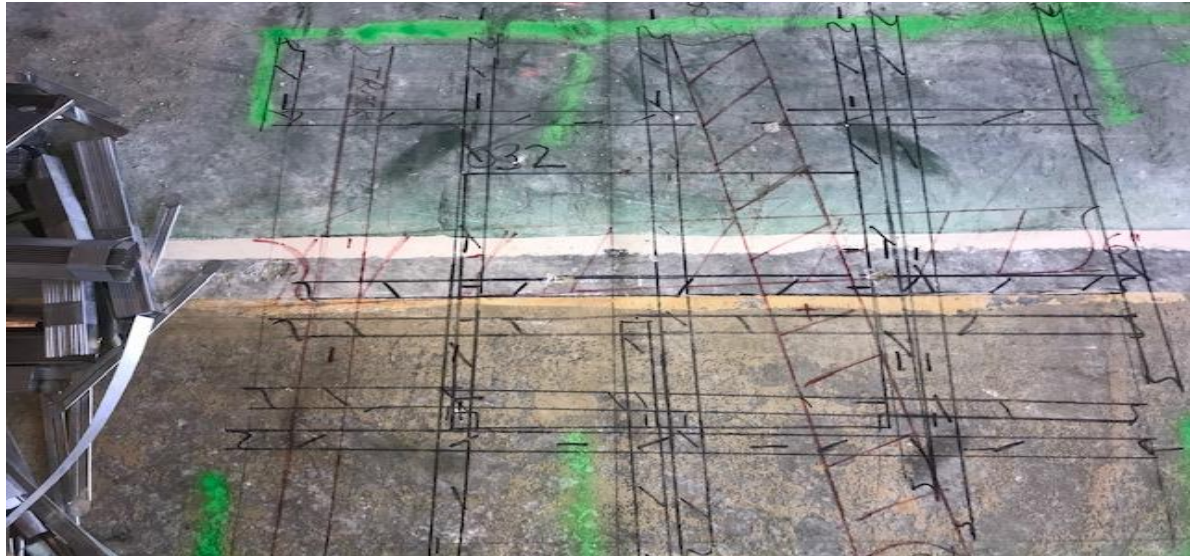
Scan #23/Denoted as 032: This scan shows a 9" slab with top and bottom layers of rebar, and multiple possible conduits, at a depth of 6" and 8" running vertically and horizontally through the slab.

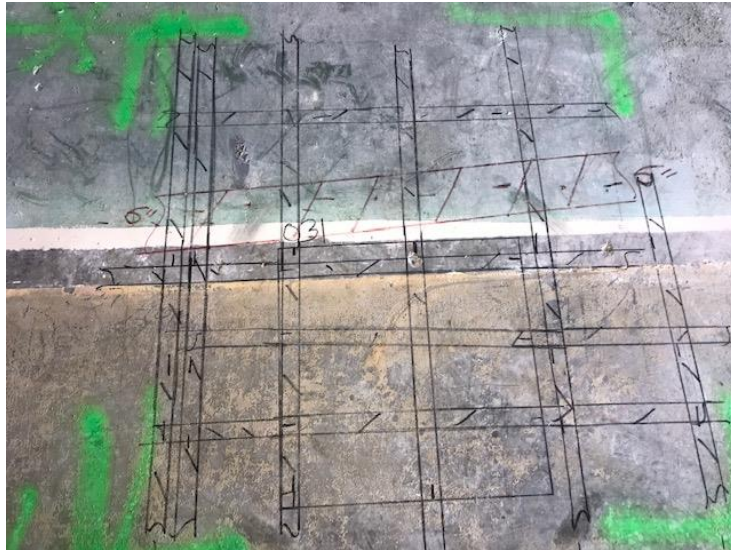
Scan #24/Denoted as 031: This scan shows a 9" slab with top and bottom layers of rebar, a possible conduit or cable, at a depth of 6" running horizontally through the slab.

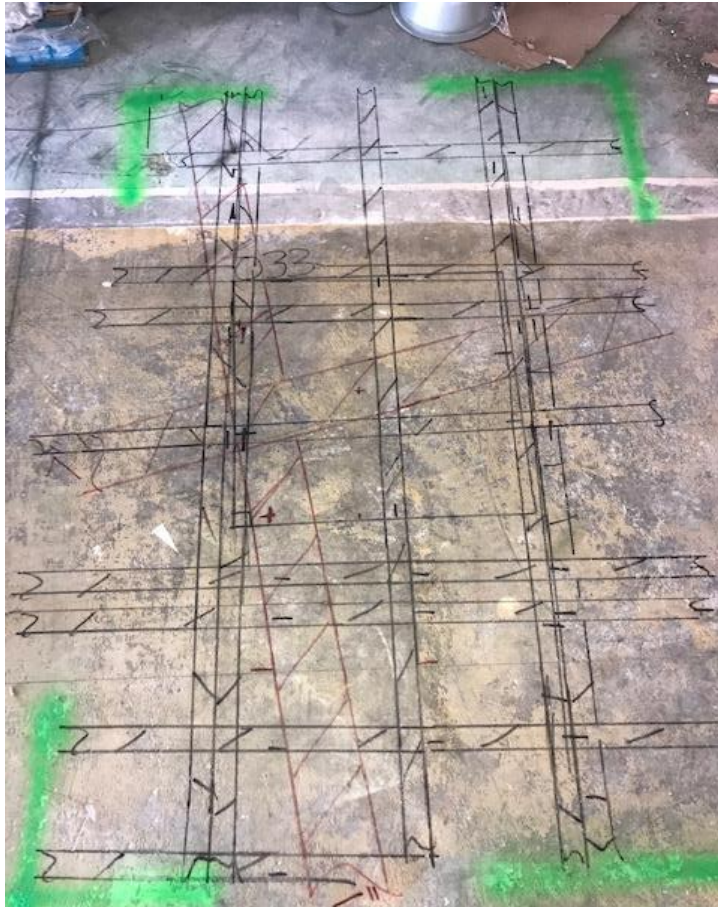
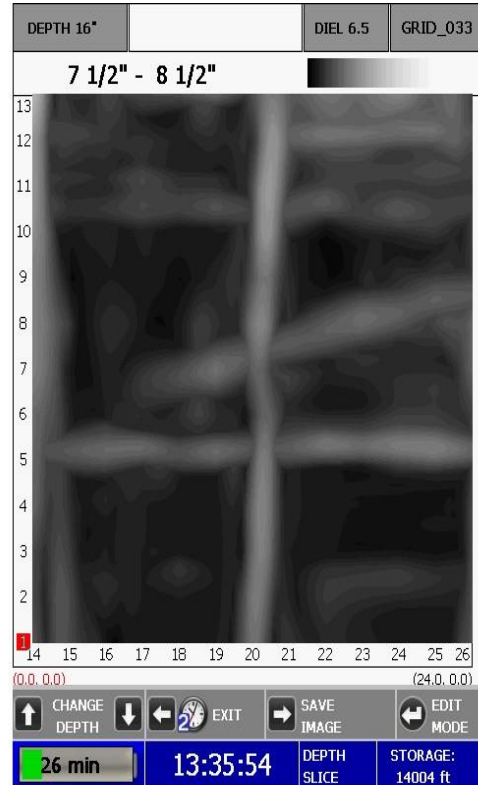
Scan #26/Denoted as 033: This scan shows an 8" slab with top and bottom layers of rebar, a two possible conduits or cables, at a depth of 7" running horizontally through the slab.

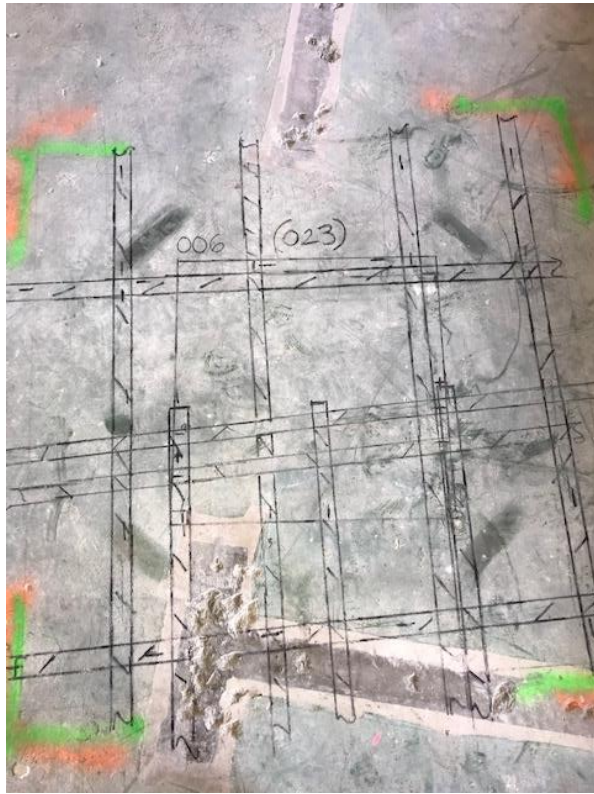
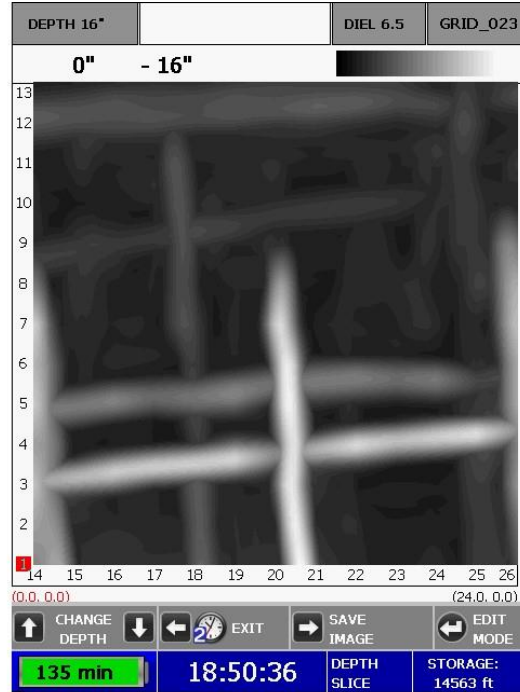
Scan #27/Denoted as 006: This scan shows an 8" slab with top and bottom layers of rebar.

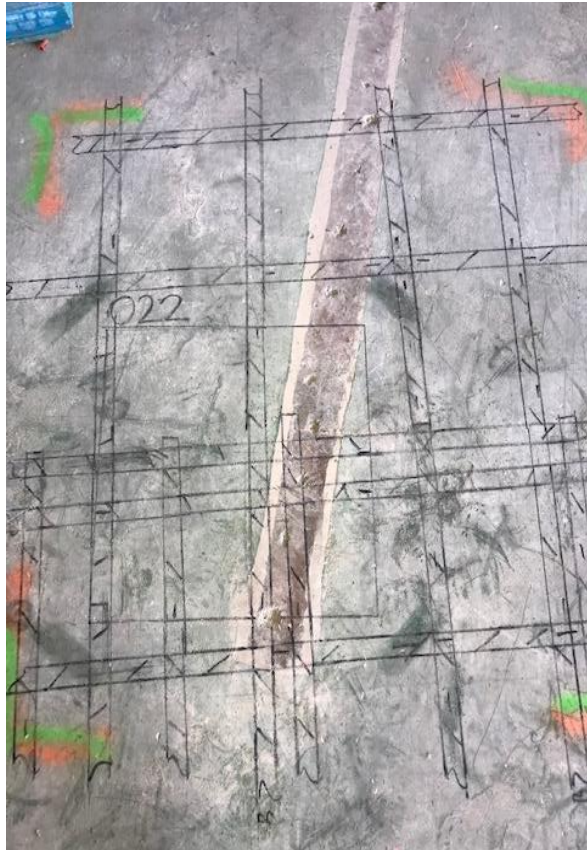
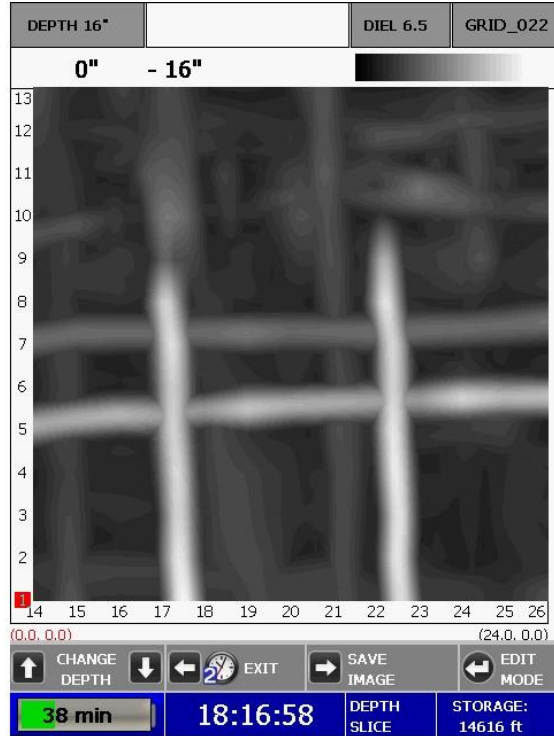
Scan #28/Denoted as 022: This scan shows an 8" slab with top and bottom layers of rebar.

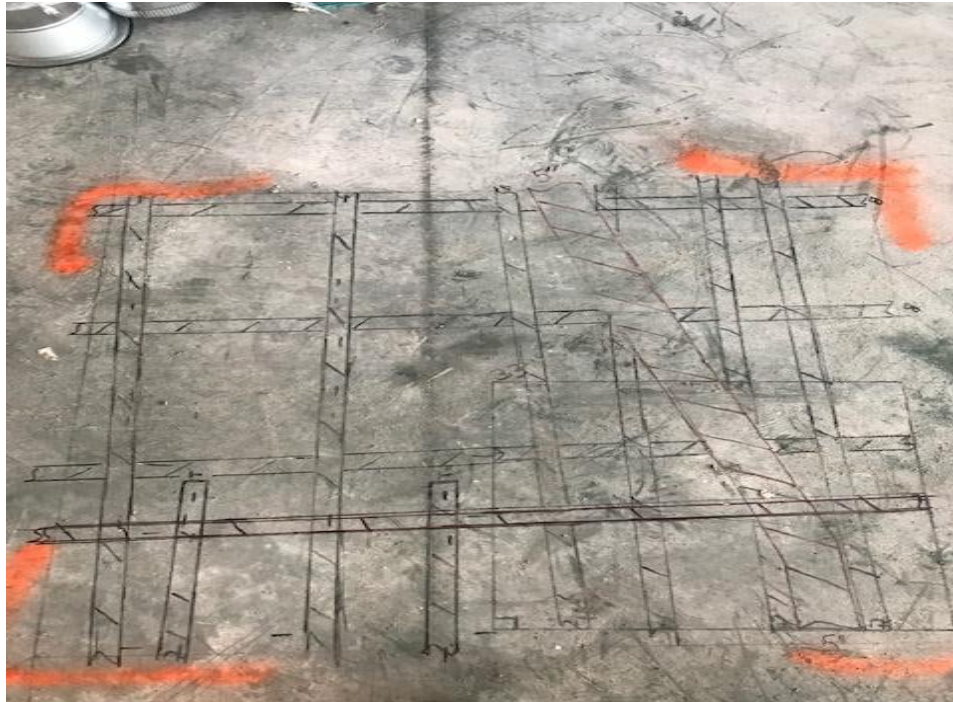
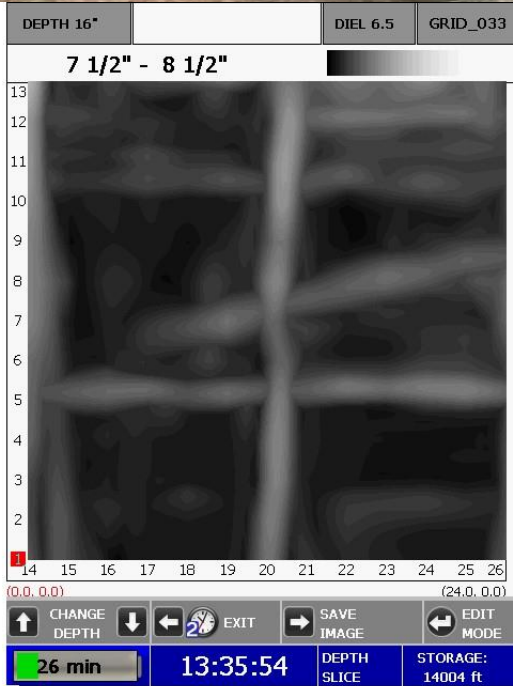
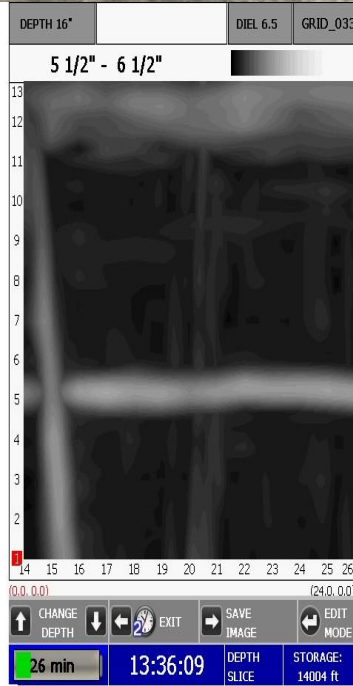
Scan #29/Denoted as 033: This scan shows an 8" slab with top and bottom layers of rebar, and a possible conduit at a depth of 5" running vertically through the grid.

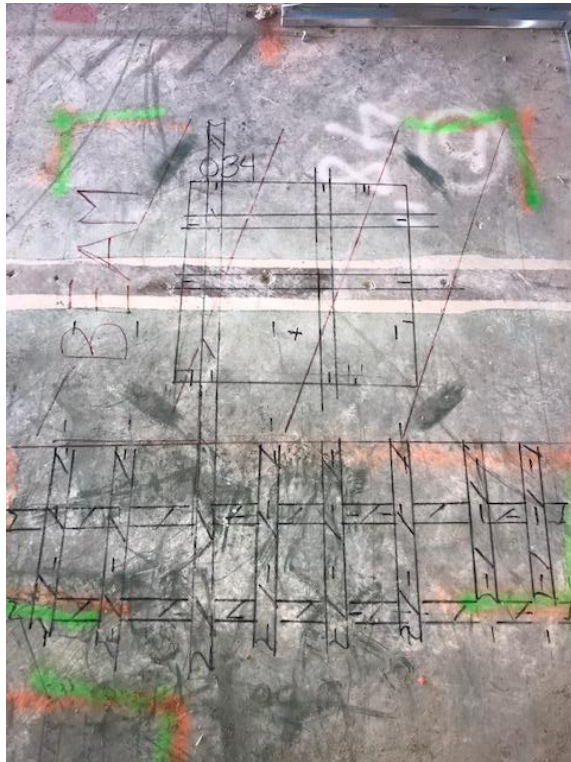
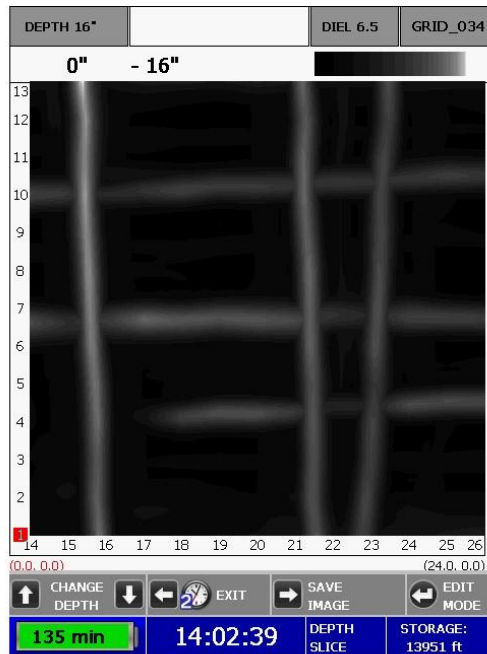
Scan #30/Denoted as 034: This scan shows an 8" slab with top and bottom layers of rebar, abutting a post-tension beam, marked in red to avoid.

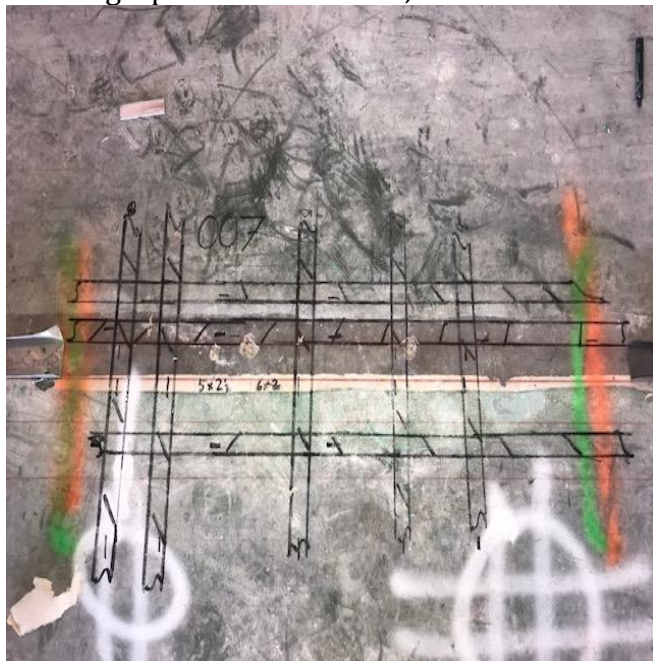
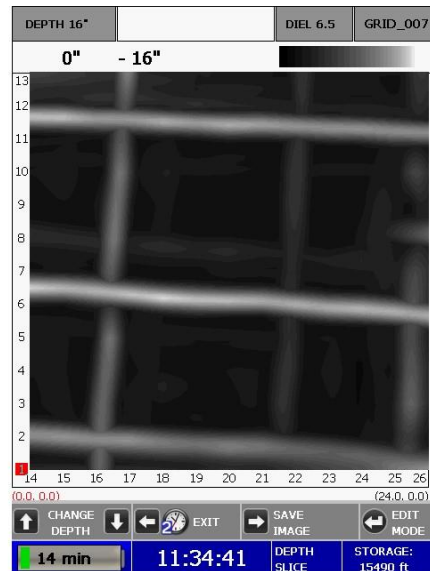
Scan #31/Denoted as 007: This scan shows an 8" slab with top and bottom layers of rebar.

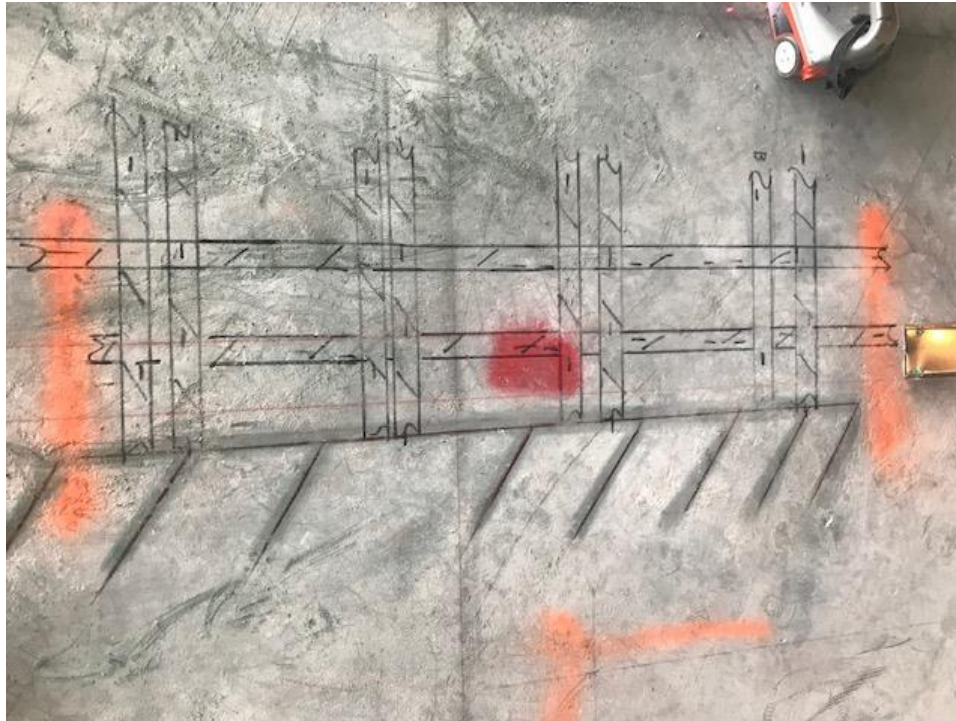
Scan #32/Denoted as 008: This scan shows an 8" slab with top and bottom layers of rebar.
