GPR report

2 February 2020

REDACTED, Executive Vice President, KasCon, requested GPR services in support of a Stein Sperling build-out located at 1101 Wootton Parkway, Rockville, Maryland on 21 January 2020. The project consists of multiple proposed penetrations on the 6th and 7th floors. The customer advised the columns/beams of this building contain post-tension cables, and were to be avoided on the job site. The remaining slab was believed to contain only rebar, which was to be marked on the slab so as to avoid while core drilling. GPR scanning was conducted on the 22-23, and 25 January 2020 on both floors; however, this GPR report will only contain the findings from the 7th floor, as the previous GPR report, dated 26 January 2020, articulated the 6th floor GPR findings. The remaining 7th floor scans, comprised of forty-four (44) scans were conducted on 31 January and 1 February 2020. To the extent possible, 2D or line scanning, was requested by the customer. However, due to site conditions, the shape of the building and consistently changing rebar patterns as a direct result, combined with multiple targets identified suggesting the presence of conduit and/or possible post ten

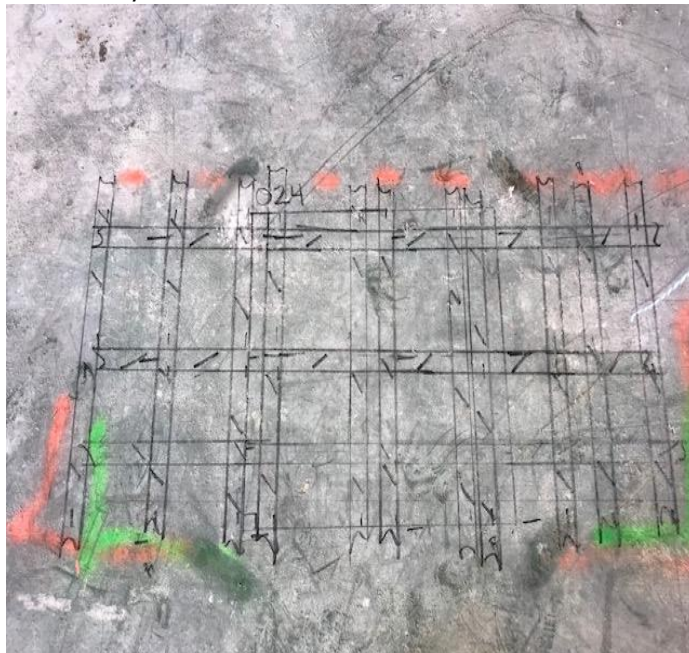
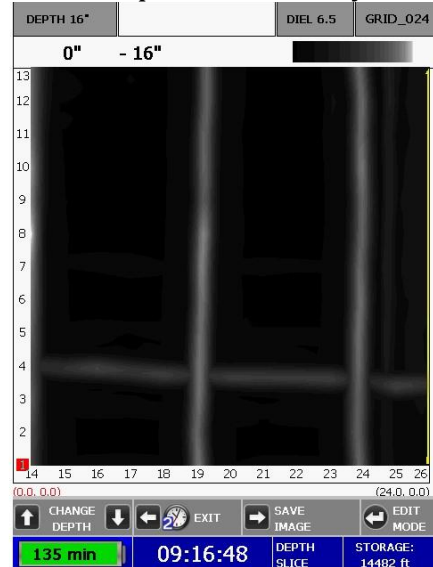
Scan #33/Denoted as 024: This scan shows an 8" slab with top and bottom layers of rebar.

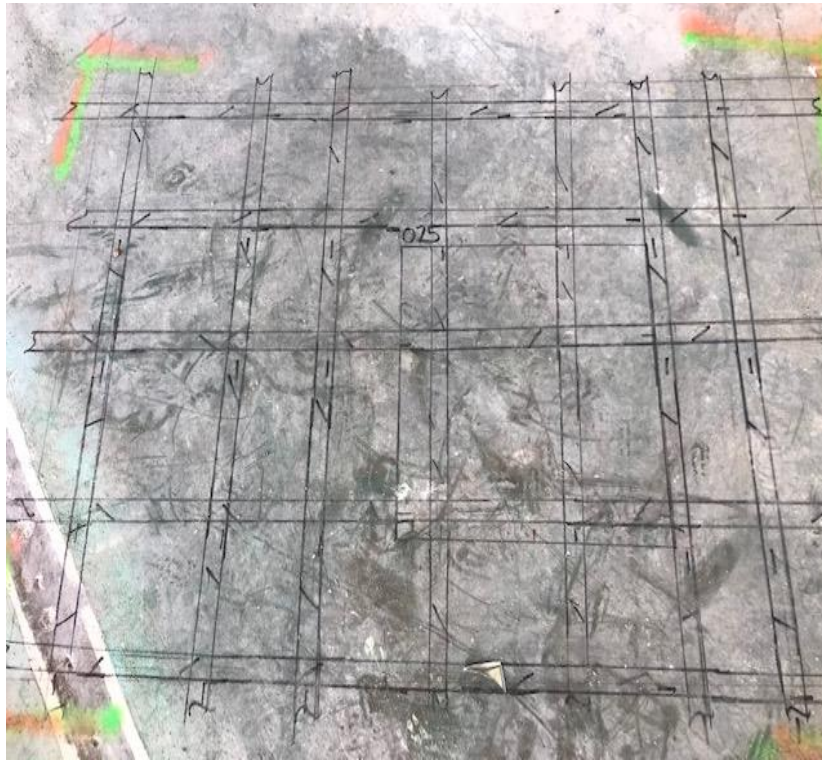
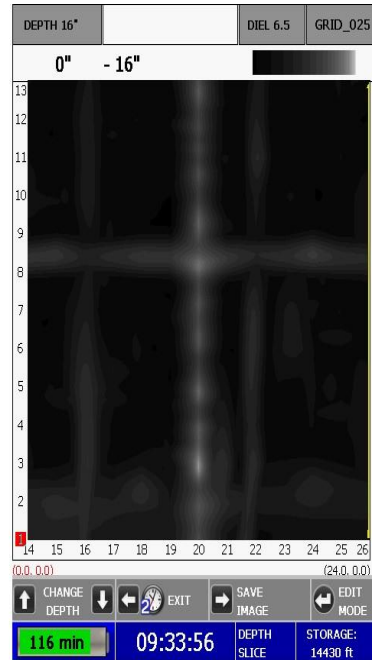
Scan #34/Denoted as 025: This scan shows an 8" slab with a bottom layer of rebar.

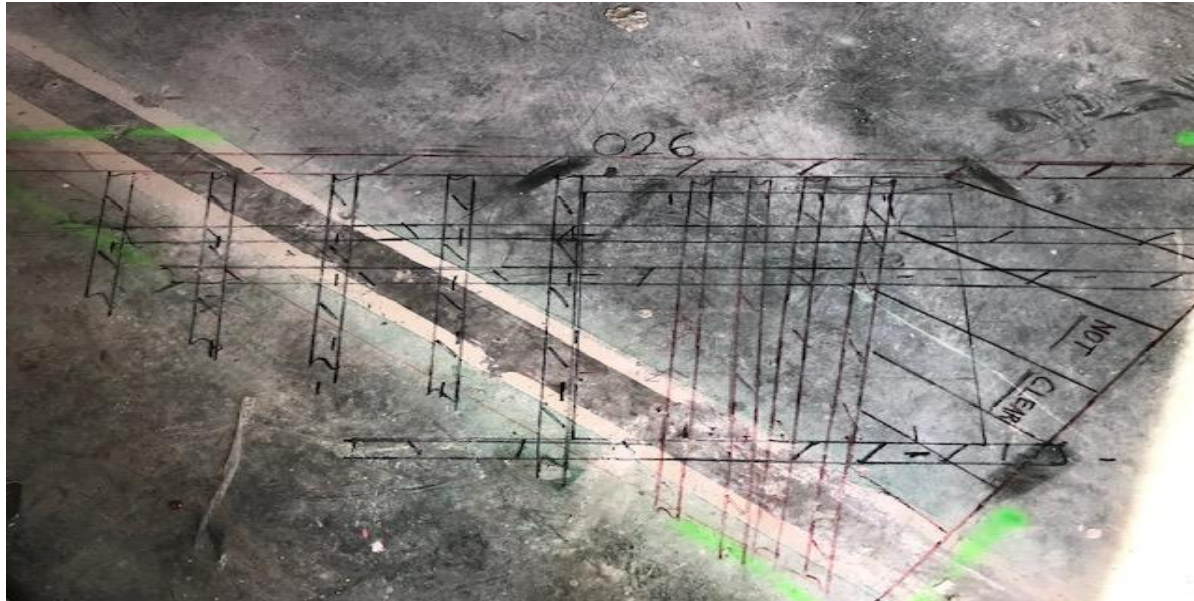
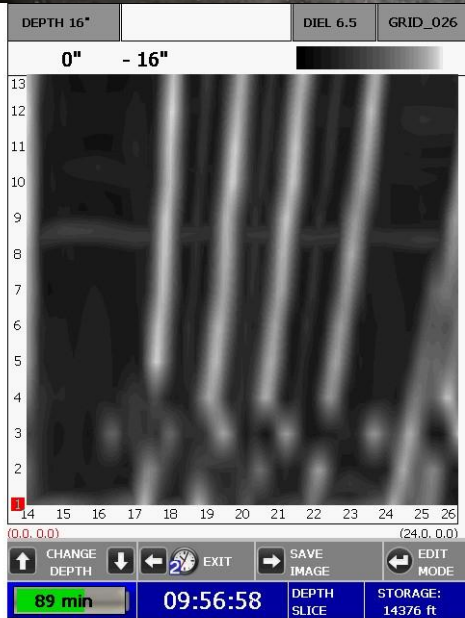
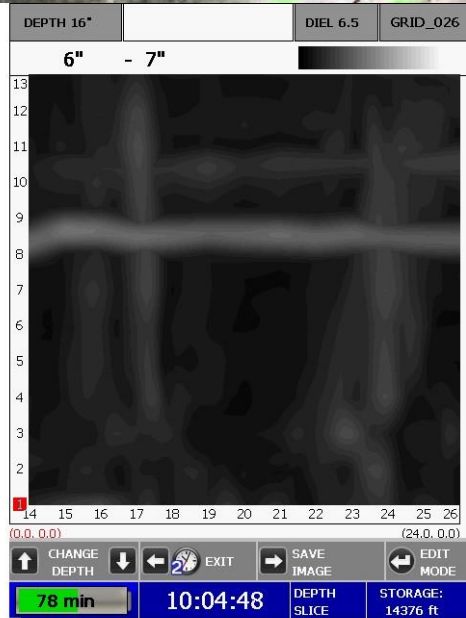
Scan #35/Denoted as 026: This scan shows an 8" slab with a bottom layer of rebar, in addition to possible cables at a depth of 5". This scan abuts a post-tension beam, which was marked in red to avoid. The data collected from the east side of this scan was not clear, and marked in red to avoid.

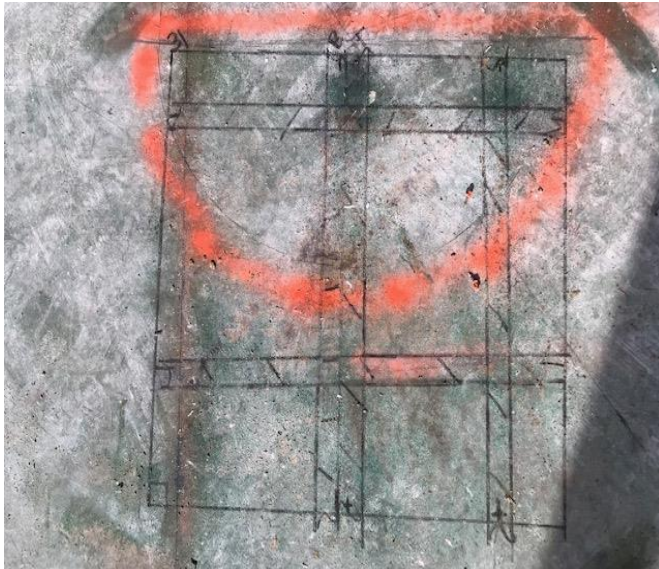
Scan #36/Denoted as 31: This scan shows an 8" slab with a top and bottom layer of rebar.

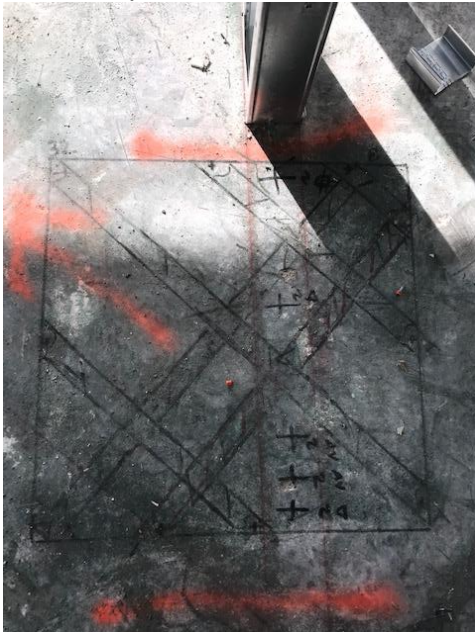
Scan #37/Denoted as 32: This scan shows an 8" slab with a top and bottom layer of rebar.

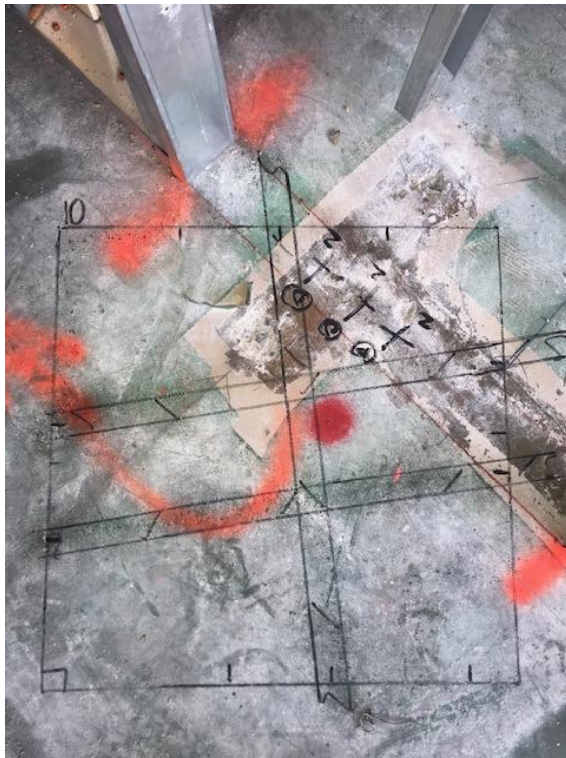
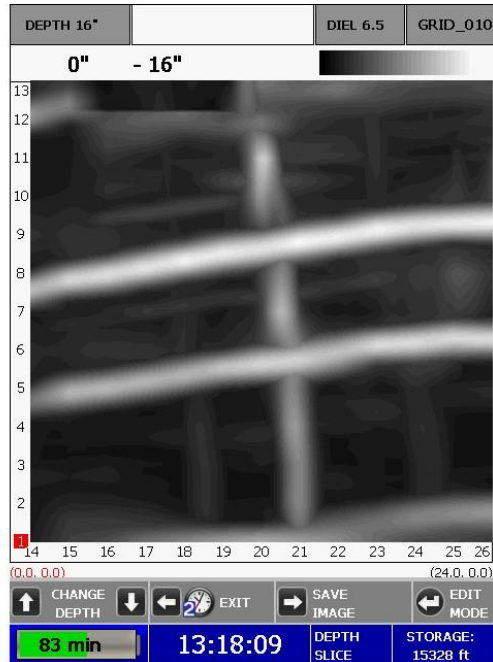
Scan #38/Denoted as 10: This scan shows an 8" slab with a bottom layer of rebar.

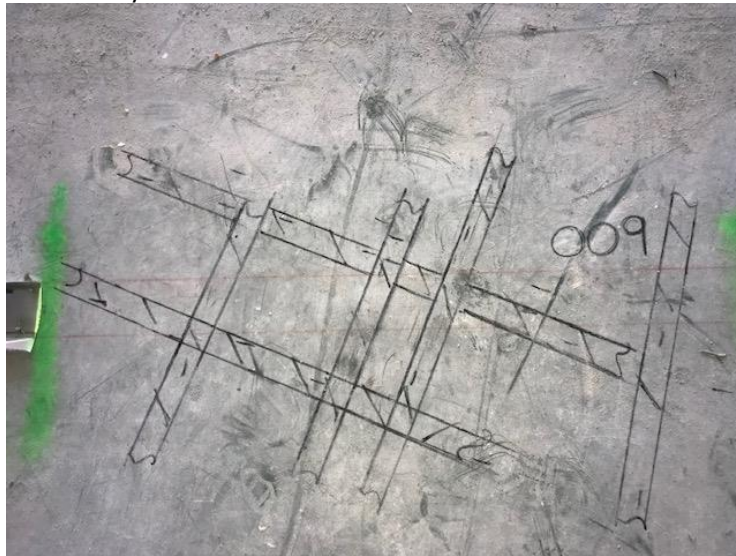
Scan #39/Denoted as 009: This scan shows an 8" slab with a bottom layer of rebar.

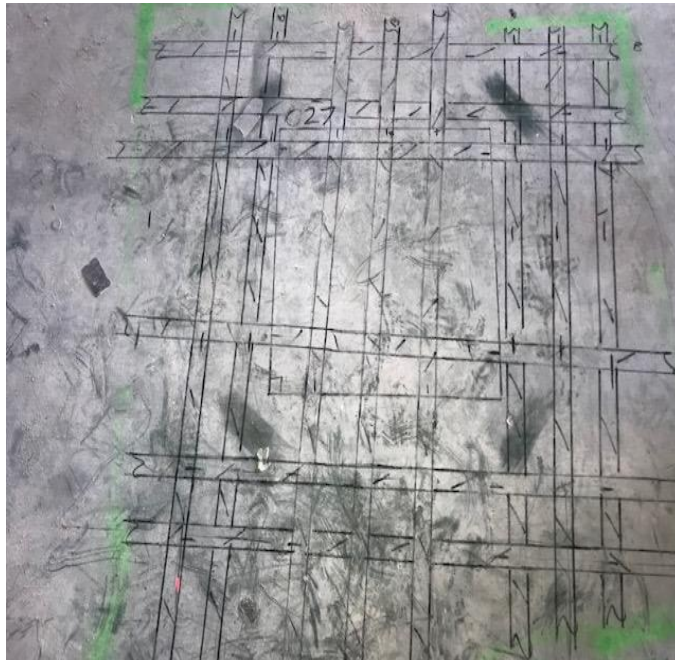
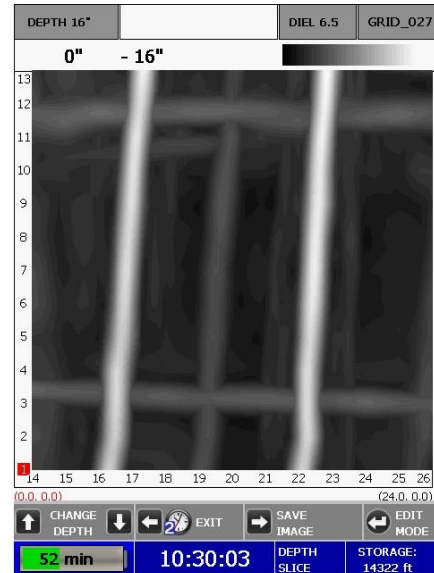
Scan #40/Denoted as 027: This scan shows an 8" slab with a top and bottom layer of rebar.

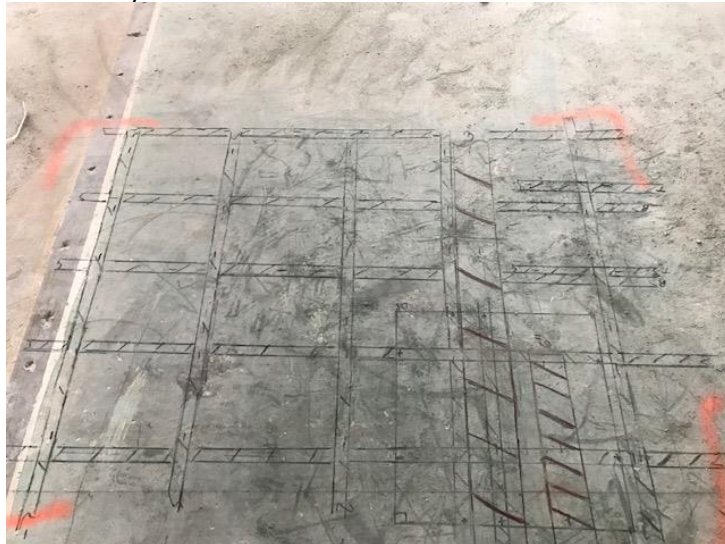
Scan #41/Denoted as 010: This scan shows an 8" slab with a top and bottom layer of rebar, with a possible conduit or cable at a depth of 3", and a second target anomalous target at a depth of 6", both of which were marked in red to avoid.

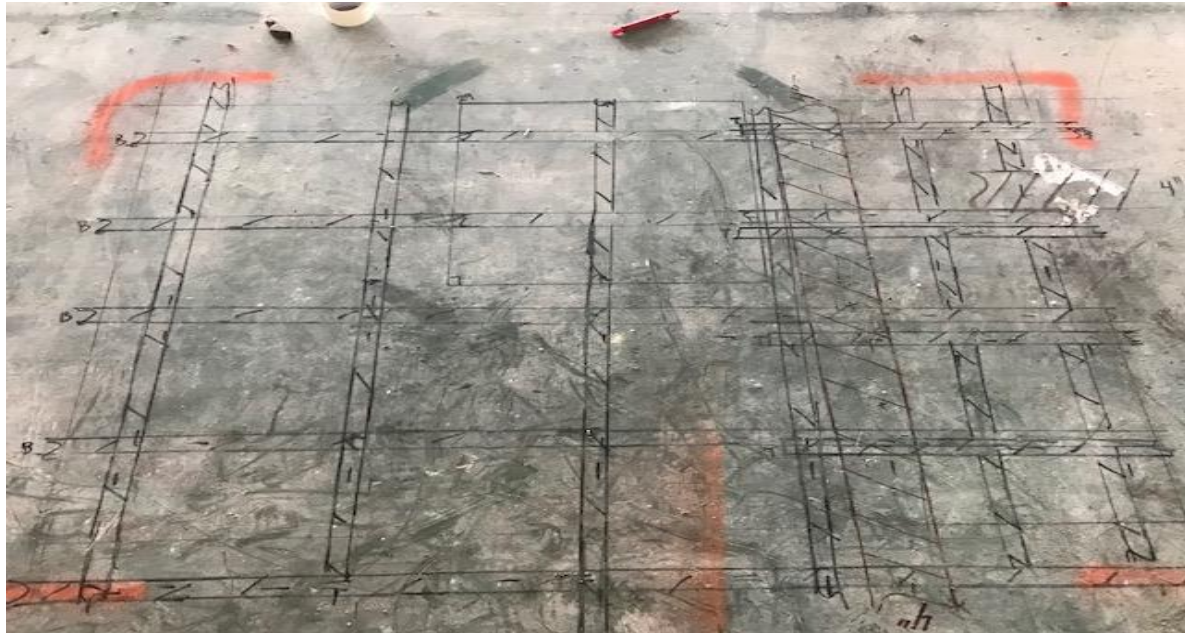
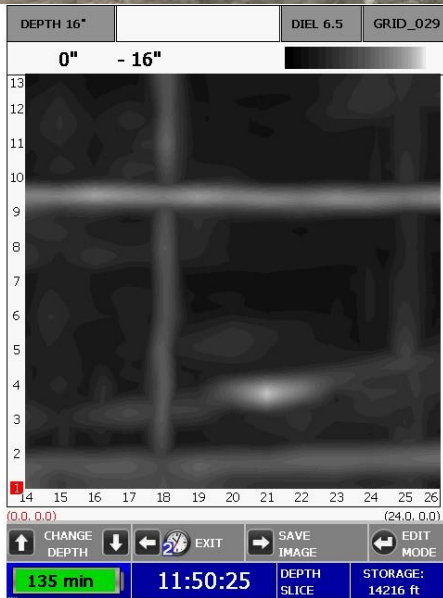
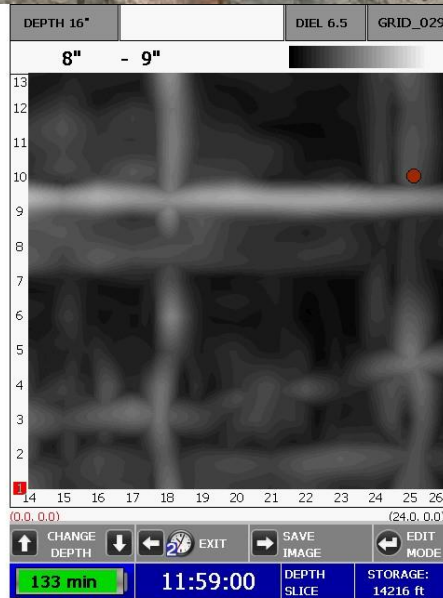
Scan #42/Denoted as 029: This scan shows an 10" slab with a top and bottom layer of rebar, with a possible conduit or cable at a depth of 4", marked in red to avoid.

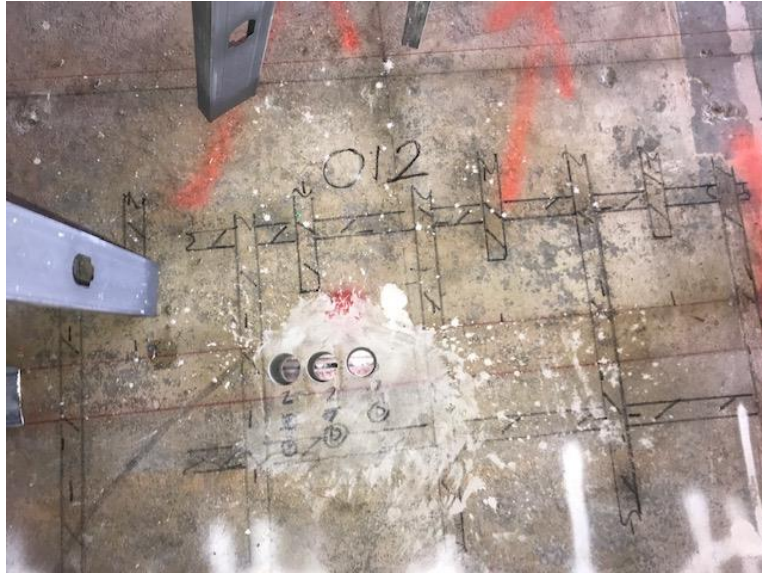
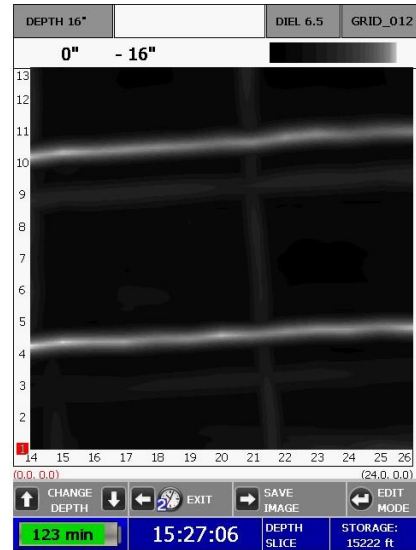
Scan #43/Denoted as 012: This scan shows an 8" slab with a top and bottom layer of rebar.

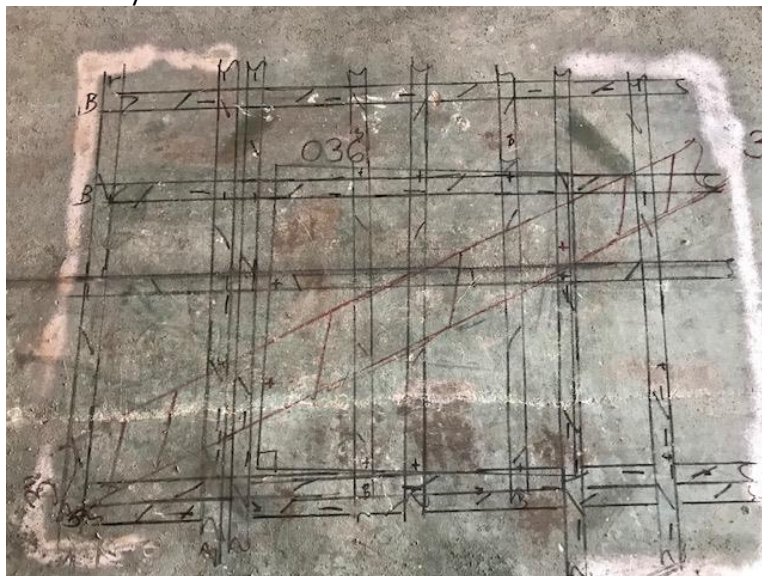
Scan #44/Denoted as 036: This scan shows an 8" slab with a top and bottom layer of rebar, and a possible conduit or cable running through the grid at a depth of 3".
