GPR report

2 February 2020

REDACTED, Executive Vice President, KasCon, requested GPR services in support of a Stein Sperling build-out located at 1101 Wootton Parkway, Rockville, Maryland on 21 January 2020. The project consists of multiple proposed penetrations on the 6th and 7th floors. The customer advised the columns/beams of this building contain post-tension cables, and were to be avoided on the job site. The remaining slab was believed to contain only rebar, which was to be marked on the slab so as to avoid while core drilling. GPR scanning was conducted on the 22-23, and 25 January 2020 on both floors; however, this GPR report will only contain the findings from the 7th floor, as the previous GPR report, dated 26 January 2020, articulated the 6th floor GPR findings. The remaining 7th floor scans, comprised of forty-four (44) scans were conducted on 31 January and 1 February 2020. To the extent possible, 2D or line scanning, was requested by the customer. However, due to site conditions, the shape of the building and consistently changing rebar patterns as a direct result, combined with multiple targets identified suggesting the presence of conduit and/or possible post ten

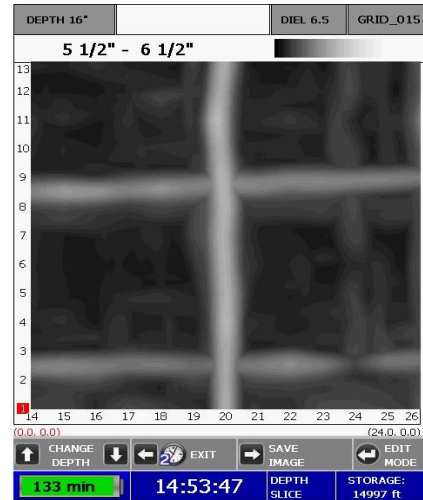
Scan #1/Denoted as 015: This scan shows an 8" slab with top and bottom layers of rebar, with a possible conduit at a depth of 8".

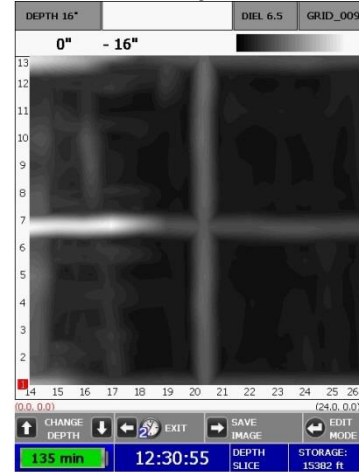
Scan #3/Denoted at 09: This scan shows an 8" slab with top layer of rebar.

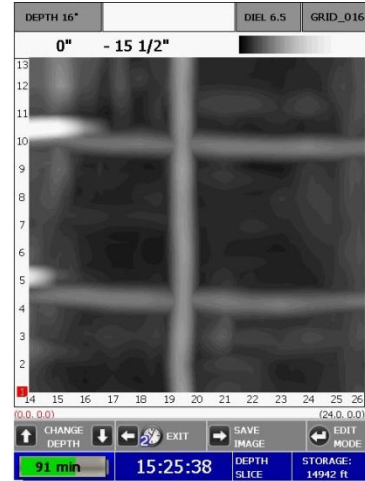
Scan #4/Denoted at 016: This scan shows an 8" slab with top and bottom layers of rebar.

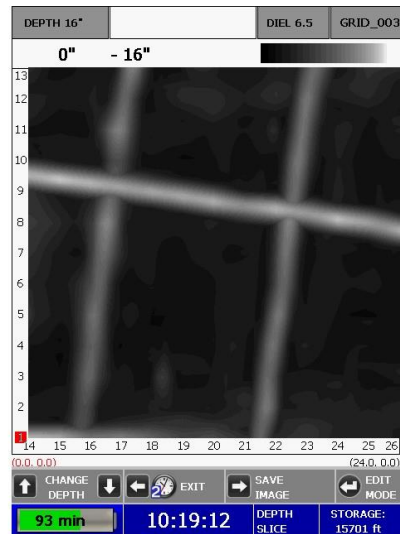
Scan #6/Denoted at 003: This scan shows an 8" slab with top and bottom layers of rebar.

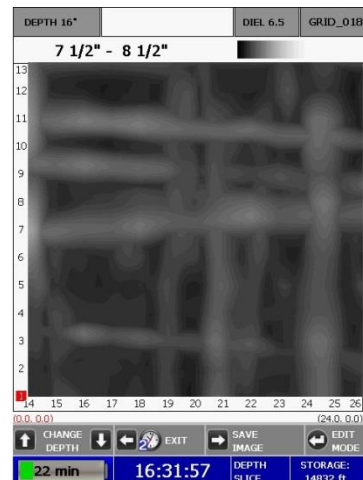
Scan #14/Denoted as 018: This scan shows an 8" slab with top and bottoms layer of rebar, with a conduit at a depth of 7". This scan abuts a post-tension beam, which was marked in red to avoid.

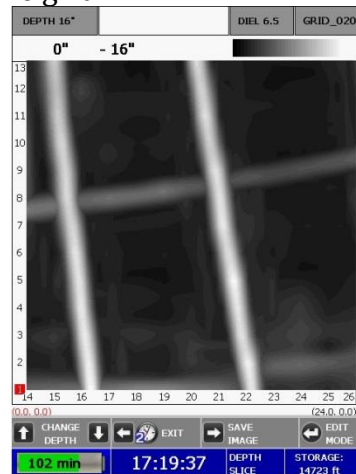
Scan #20/Denoted as 020: This scan shows an 8" slab with a bottom layer of rebar.

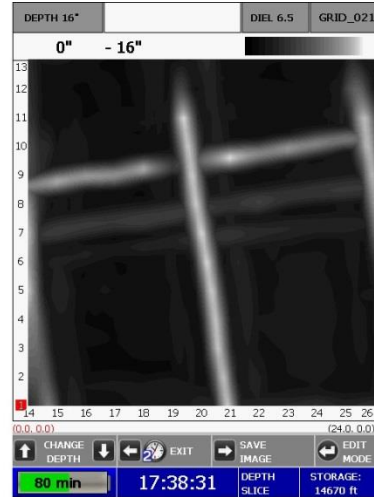
Scan #21/Denoted as 021: This scan shows an 8" slab with top and bottom layers of rebar.

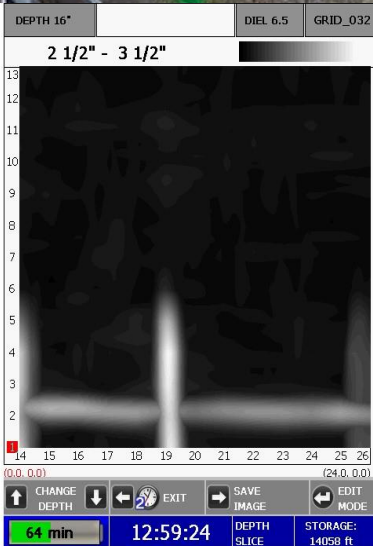
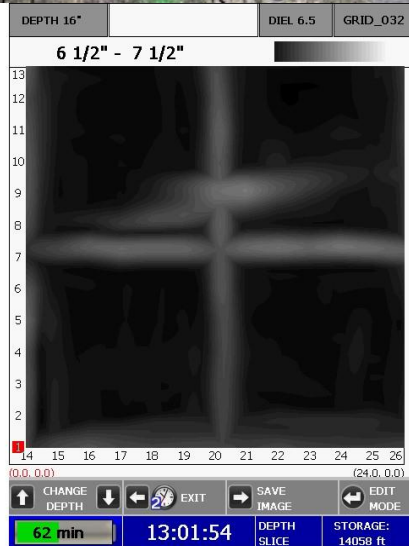
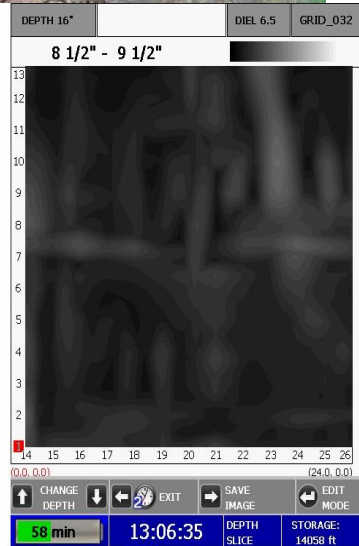
Scan #23/Denoted as 032: This scan shows a 9" slab with top and bottom layers of rebar, and multiple possible conduits, at a depth of 6" and 8" running vertically and horizontally through the slab.

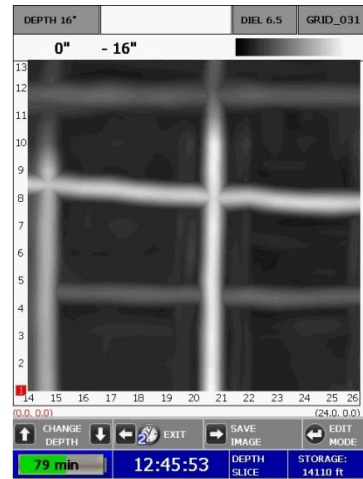
Scan #24/Denoted as 031: This scan shows a 9" slab with top and bottom layers of rebar, a possible conduit or cable, at a depth of 6" running horizontally through the slab.

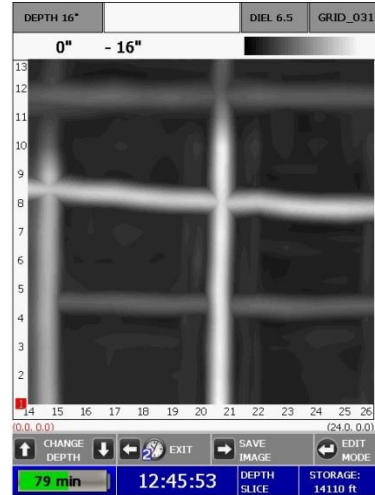
Scan #36/Denoted as 31: This scan shows an 8" slab with a top and bottom layer of rebar.

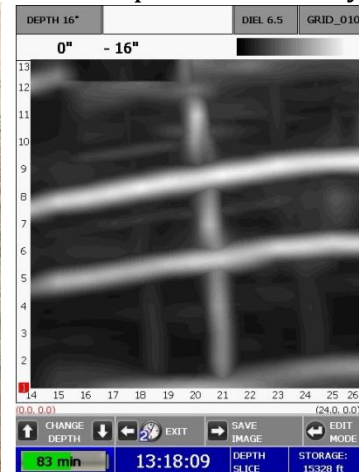
Scan #41/Denoted as 010: This scan shows an 8" slab with a top and bottom layer of rebar, with a possible conduit or cable at a depth of 3", and a second target anomalous target at a depth of 6", both of which were marked in red to avoid.

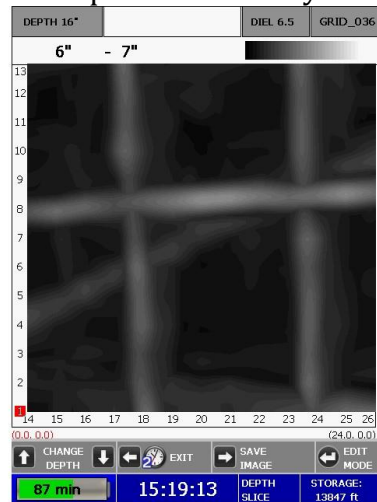
Scan #44/Denoted as 036: This scan shows an 8" slab with a top and bottom layer of rebar, and a possible conduit or cable running through the grid at a depth of 3".
